Memorandum

09 April 2018

To	Banana Shire Council		
Copy to	Ray Geraghty (Chief Executive Officer - Banana Shire Council)		
From	Greg Penhaligon (Senior Civil Engineer - GHD)	Tel	(07) 4973 1600
Subject	Gibihi Road Alternative Access	Job no.	42/20370

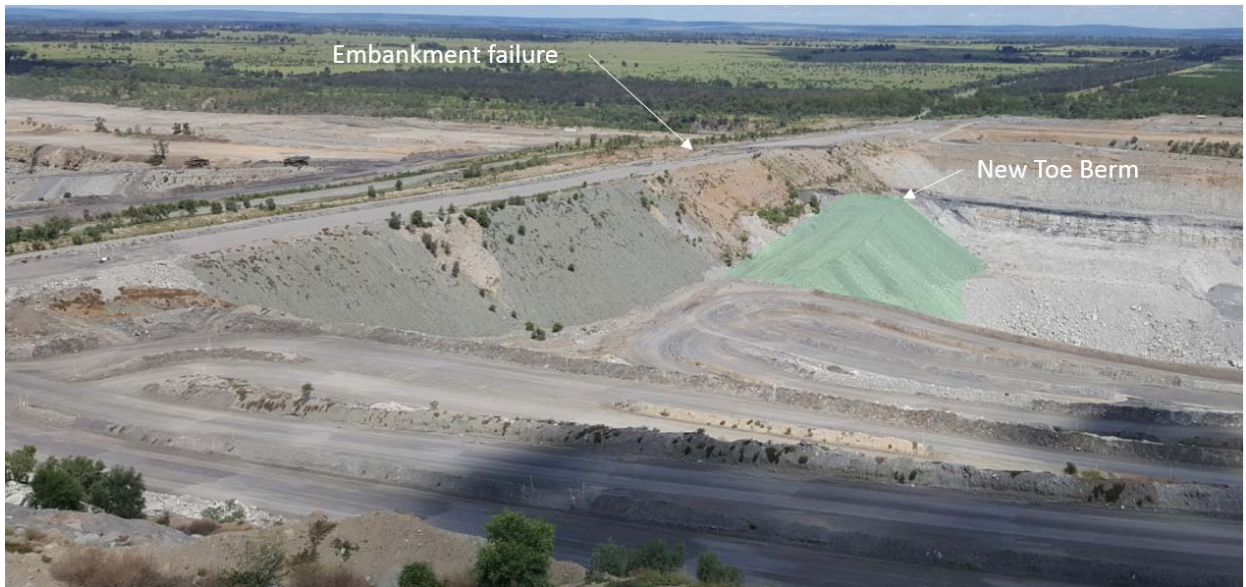
Anglo American had installed a toe berm at the base of the failed embankment to shore up the road (as shaded green in Figure 1) and protect its own mining operations.

Figure 1 Newly Installed Toe Berm

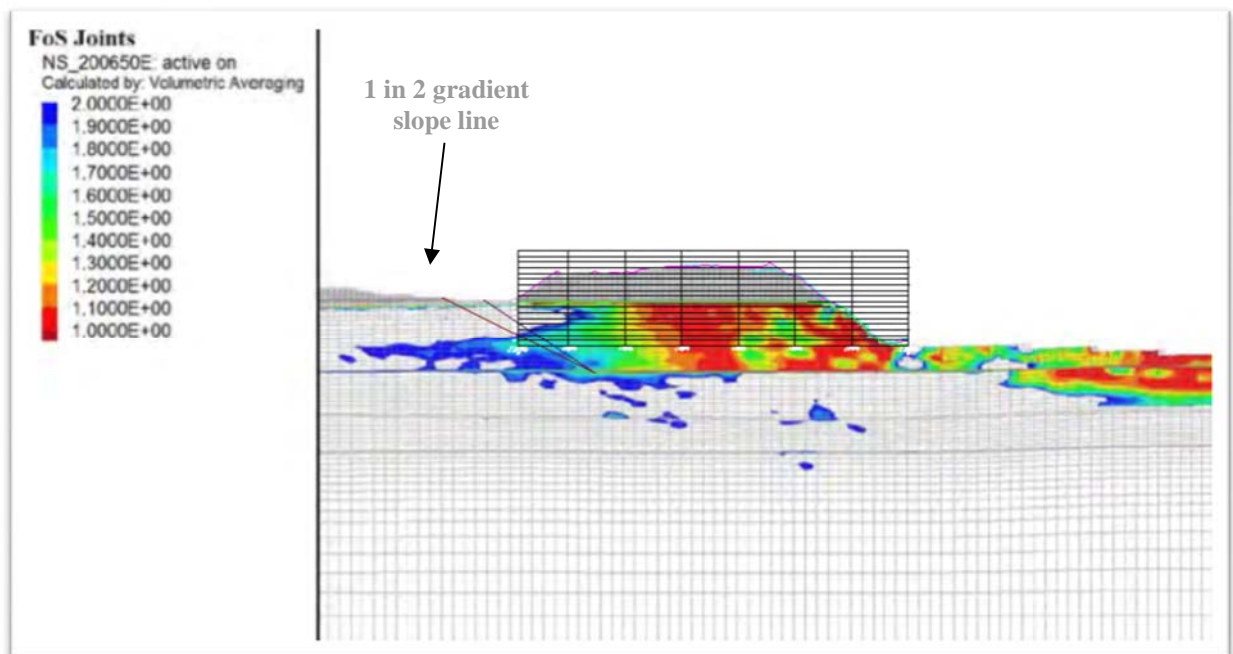
Figure 4: Factor of safety chart at 200650E with cross section and safe slopes shown

The results of the assessment of the safety exclusion zone a FOS below 1.5 using batter slopes of 1V:1.5H and 1V:2H is some 210m to 270m from the existing road formation. This places the alternate alignment outside of the road reserve.

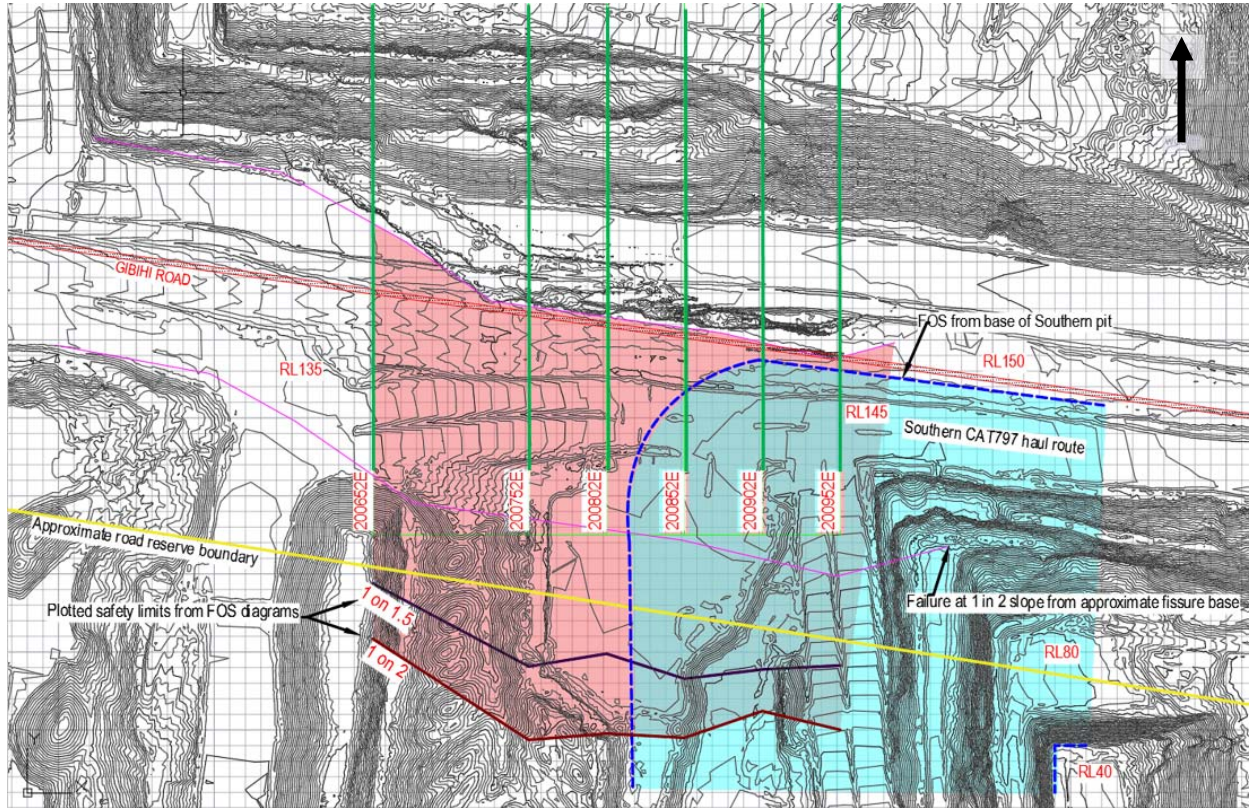
The safety limits plotted from the FOS diagram are indicated for 1V:1.5H and 1V:2H are indicated in black and red lines respectively on Figure 5. The estimation of these safety limits do not include the TMR requirement for a 4 metre wide bench for every 10m vertically of batter. The red shaded area on the figure indicates the safety exclusion zone with a FOS below 1.5 unsuitable for public road construction resulting from the block shift failure. These lines extend well past the road reserve boundary into the mine lease (approximately 250m to the south of the existing Gibihi Road formation). The area also covers the south mine haul route used by Anglo American.

The magenta line on Figure 5 indicates the arbitrary 1 in 2 line from the initial estimated base of the fissure resulting from the block shift. Given the depth of the fissure could as deep as 90 metres and there is no allowance for the four metre wide TMR benches, the safety exclusion line could easily be outside of the road reserve.

Figure 5 Plotted location of sections and Factor of Safety Lines (Base information from Anglo American).

The blue dashed line represents the potential influence of the existing mine excavation of the southern pit at a slope of 1V in 2H from the base of the pit at RL 40m (without 4m earthworks benches). The blue shaded area on Figure 5 indicates the safety exclusion area resulting from the mine excavation with a FOS below 1.5 unsuitable for public road construction.

From the above assessment of areas with a factor of safety suitable to construct a permanent alternative route for Gibihi Road, with the safety exclusion area from the existing southern pit excavation overlapping with the unsuitable FOS area from the block shift failure, an alternative route is precluded from being constructed between the existing Gibihi Road formation and the southern mine pit.

Given the stability of the corridor between the block shift failure and the mining operations have a factor of safety less than 1.5, further investigation of an alternative road alignment is not recommended within the road reserve for Gibihi Road.

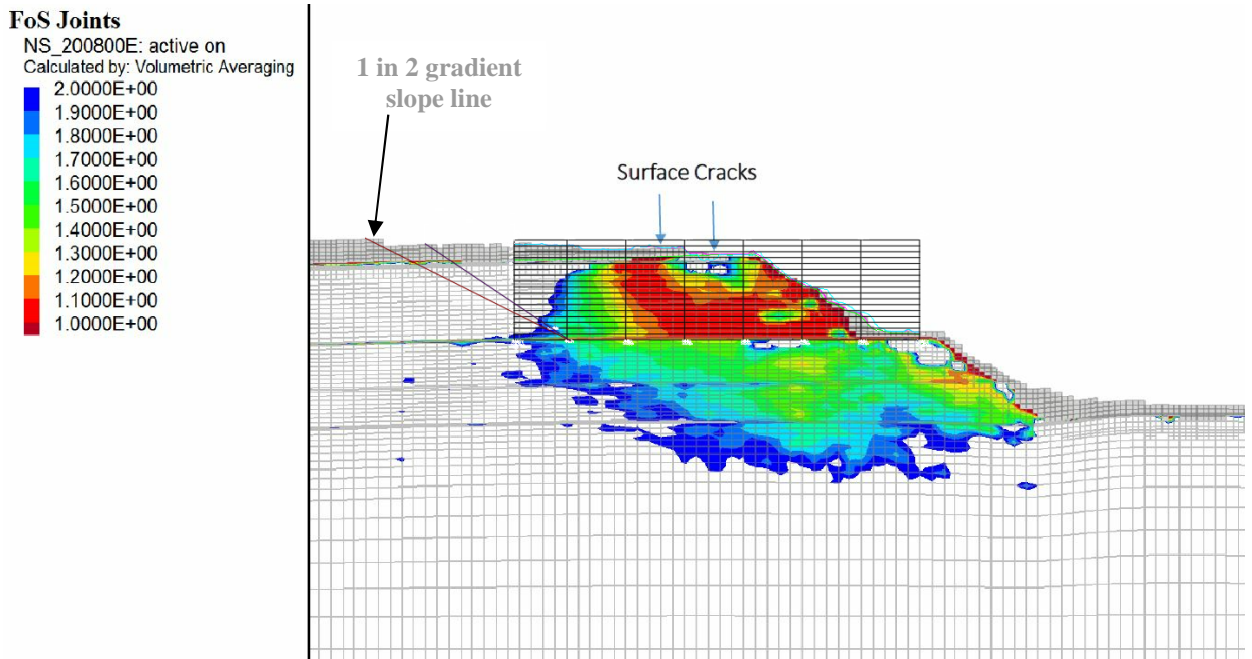
Figure 6: Factor of safety chart at 200800E with cross section and safe slopes shown

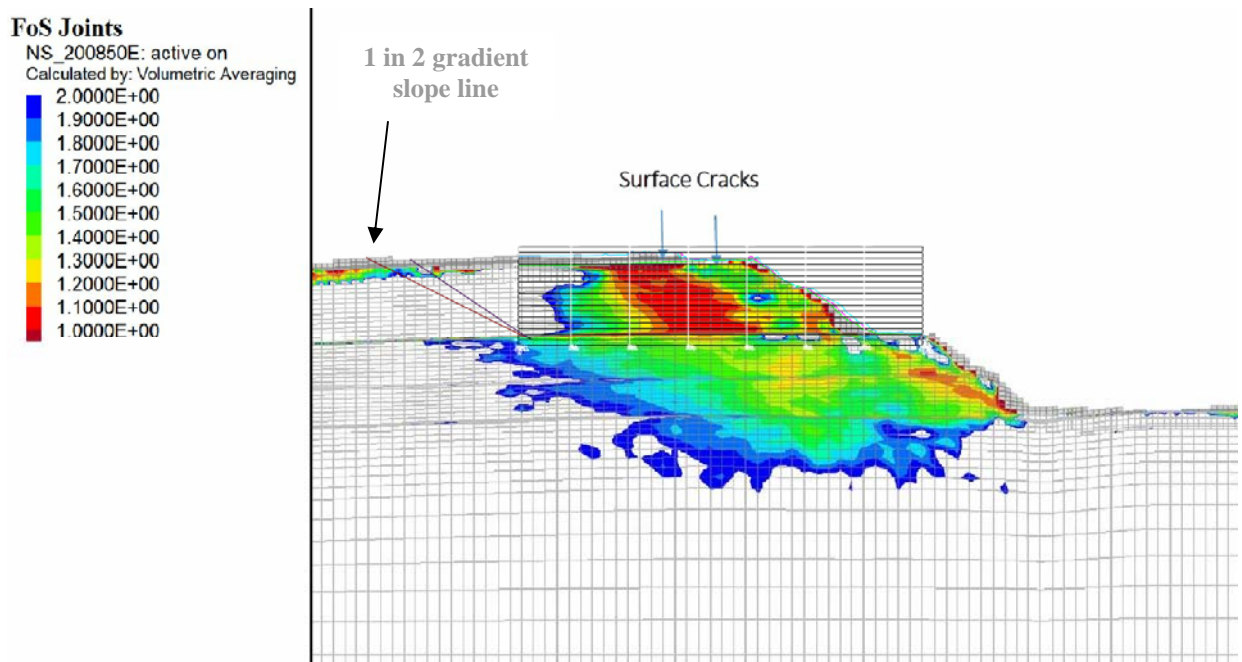
Figure 7: Factor of safety chart at 200850E with cross section and safe slopes shown

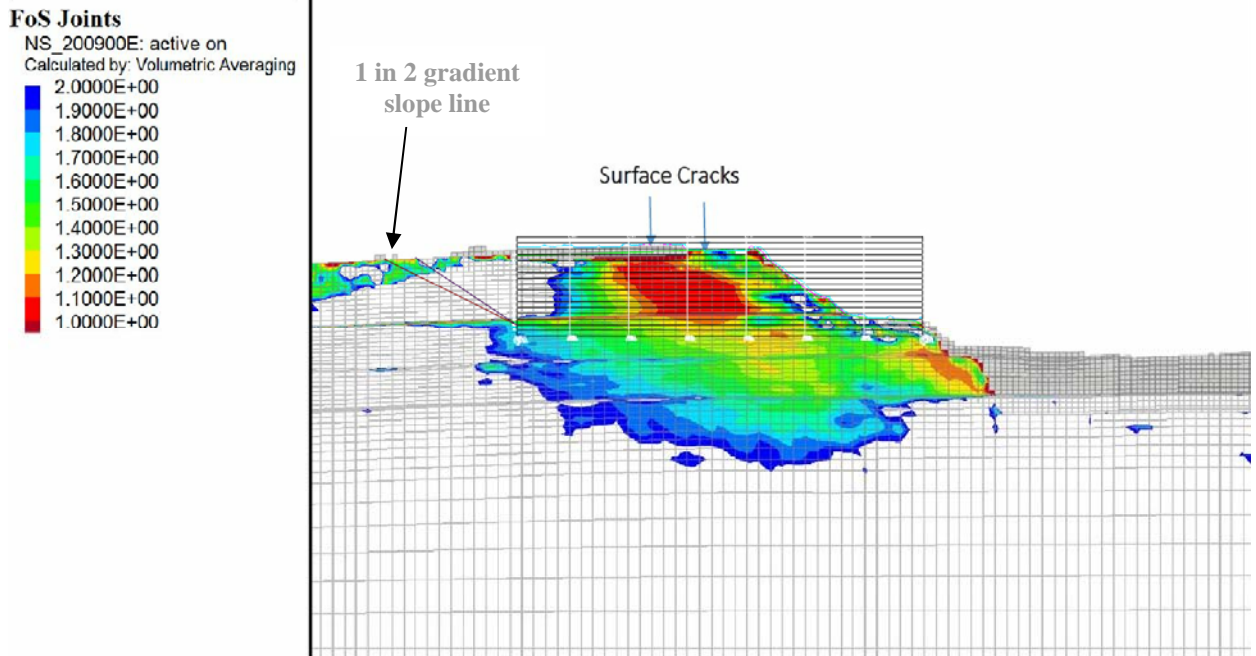
Figure 8: Factor of safety chart at 200900E with cross section and safe slopes shown
