Taroom Reservoir Cleaning report 2021

Theodore Reservoir Cleaning report 2021

Structure ID:	Taroom WTP			Client:	Banana Shire Council						
Structure Type:	Reservoir			Contact:	Miguel Escobar						
Construction Type:	Concrete			Owner:	BANANA SHIRE COUNCIL						
Inspection Type:	Clean & Inspect			Asset Location:	6 Cranmar Street, TAROOM, Qld						
Inspector:	J Pearson C Huckauff			Lat Long:							
Inspection date:	Saturday 28 th August 2021			Report No.:	1423-2021-15						
Inspection Level 1	<input checked="" type="checkbox"/>	Inspection Level 2	<input type="checkbox"/>	Inspection Level 3	<input type="checkbox"/>	Exceptional	<input type="checkbox"/>	Programmed	<input checked="" type="checkbox"/>	Underwater	<input checked="" type="checkbox"/>
Potable Water	<input checked="" type="checkbox"/>	NON Potable Water	<input type="checkbox"/>	Contaminated Diving	<input type="checkbox"/>	Sediment Cleaning	<input checked="" type="checkbox"/>	Samples required	<input type="checkbox"/>	Disinfection	<input type="checkbox"/>

Theodore Reservoir Cleaning report 2015

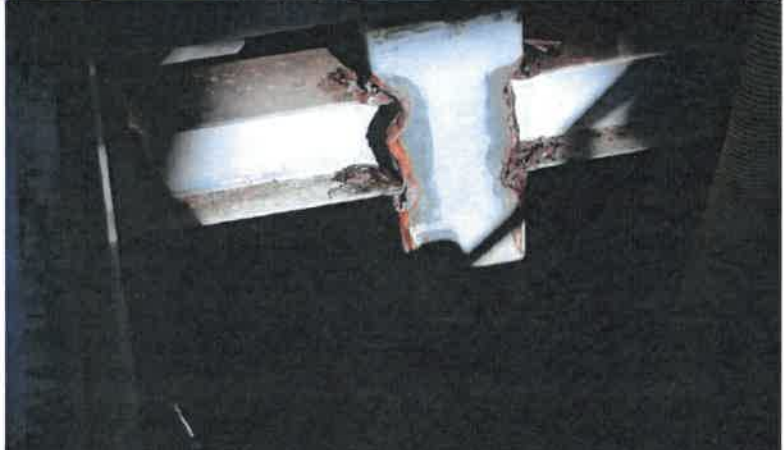
1-4	Hatch		
Description:			
Moderate rust on support frame bracing

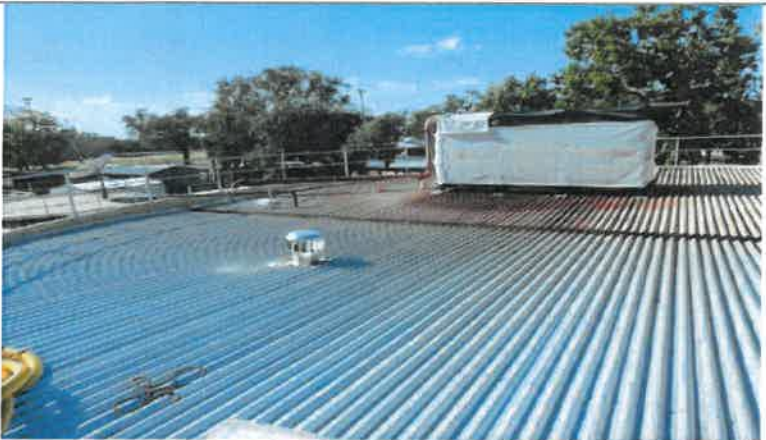
Reference:	Component:	ID:
1-5	Roof

- Moderate rust on support frame bracing	1.4
Roof Platforms	D	8	No noticeable issues.	1.3
Walkways	-	-	No walkways.	
Roof	A	4	- Timber frame structure on roof is not fully sealed and external elements can enter reservoir.	1.5

Unknown frame on roof

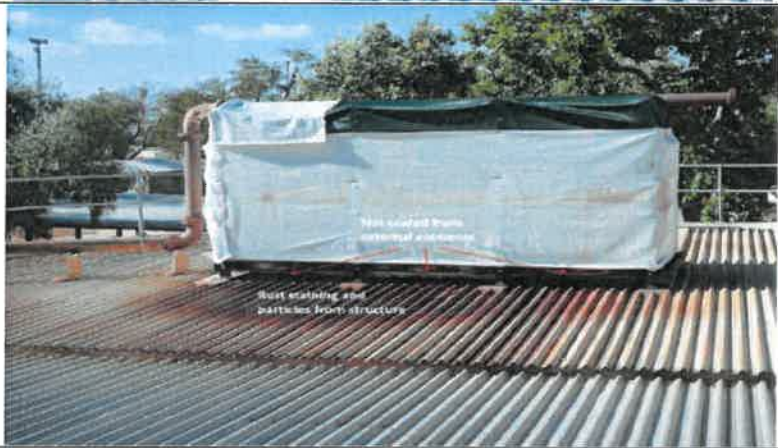
Reference:	Component:	ID:
1-6	Roof

Unknown structure:
 - Not sealed from external elements
 - Rust staining and particles from structure

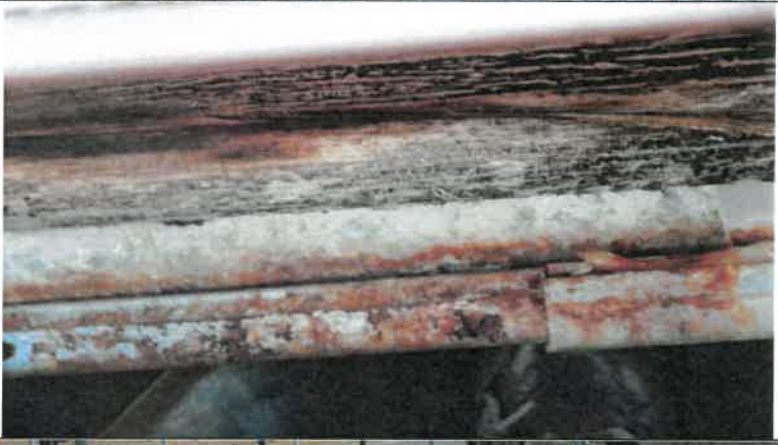
Reference:	Component:	ID:
1-7	Roof

- Timber frame structure has rot on 90x90 Hardwood post supports.	1.6
			- Rust is noticeable in vicinity of timber frame structure.	1.7
			- There is a galvanised pipe on the roof that is only supported by bricks on iron sheeting with no noticeable bracing to roof support beams.	1.8

Unknown structure:
 - Hardwood timber supports has extensive moisture and rot.

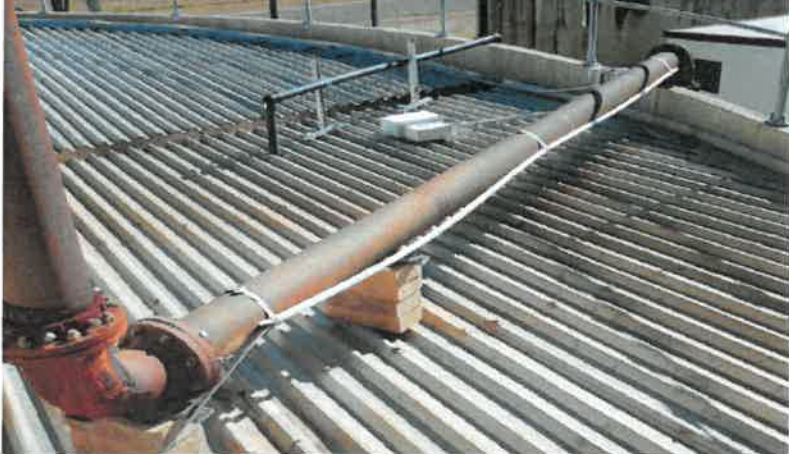
Reference:	Component:	ID:
1-8	Roof

There is a galvanised pipe on the roof that is only supported by bricks on iron sheeting with no noticeable bracing to roof support beams.

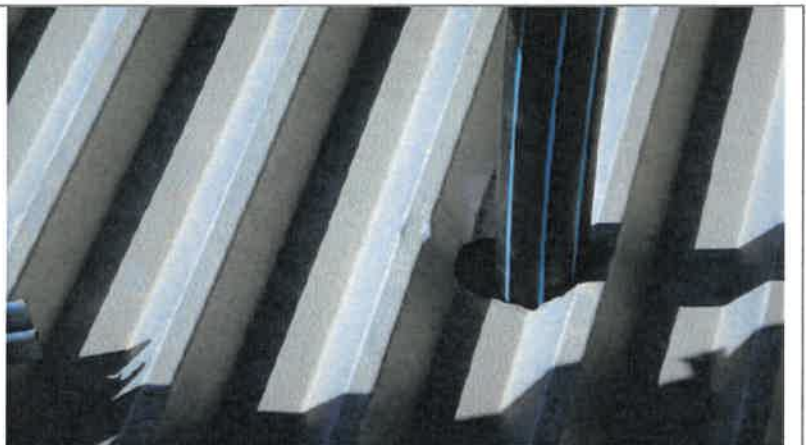
- New pipe penetrations on roof are not fully sealed.	1.9
Handrails	D	8	Appears to be in good order	1.5
Davit	-	-		
Ventilation	D	8	Appears to be in good order	1.5
Bird Proofing	-	-		
Electrical	-	-		
Level Indicator	D	9	Appears to be working	1.1
Others:	A

Reference:	Component:	ID:
1-9	Roof	
Description:		
New pipe penetrations on roof are not fully sealed.

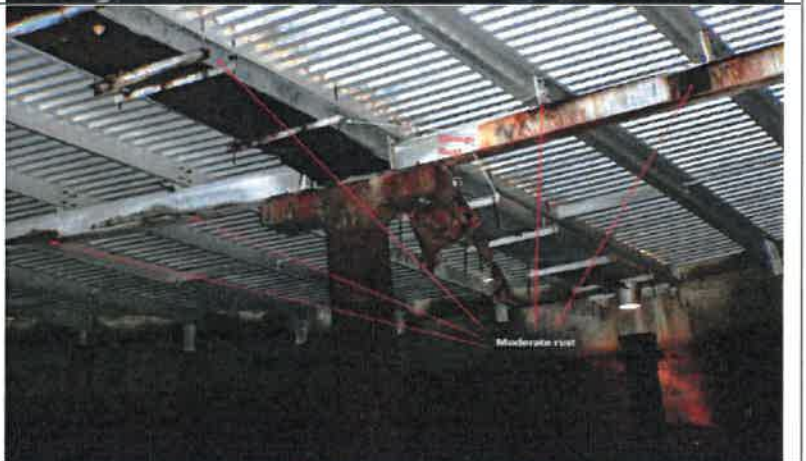
Reference:	Component:	ID:
1-10	Roof	
Description:		
Moderate rust on girders and column support brackets.

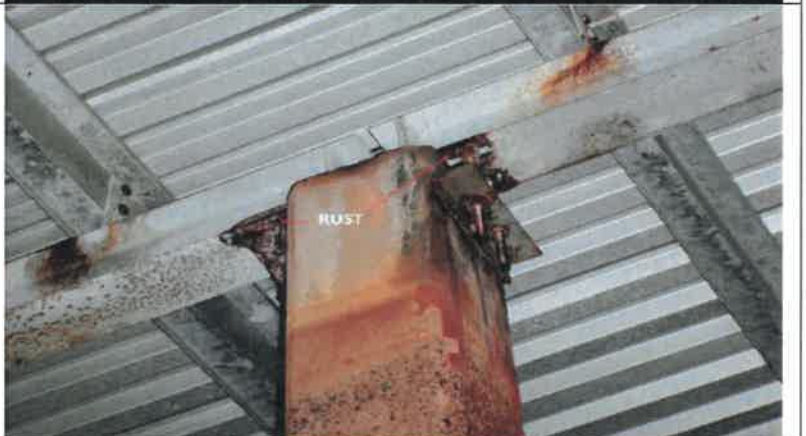
Reference:	Component:	ID:
1-11	Roof	
Description:		
Moderate rust on girders and column support brackets.

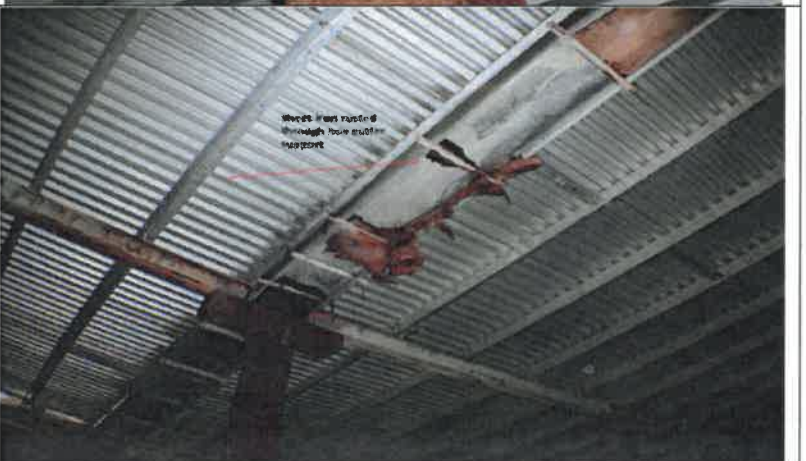
Reference:	Component:	ID:
1.12	Roof	
Description:		
Moderate / severe rust on box gutter support bracing and sheeting that is hanging.

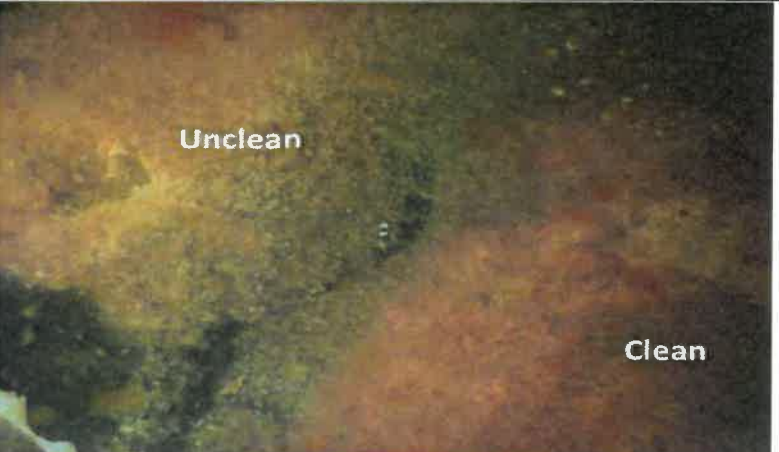
1.15	Sediment		
Description:			
250 – 300mm sediment			
Reference:	Component:	ID:

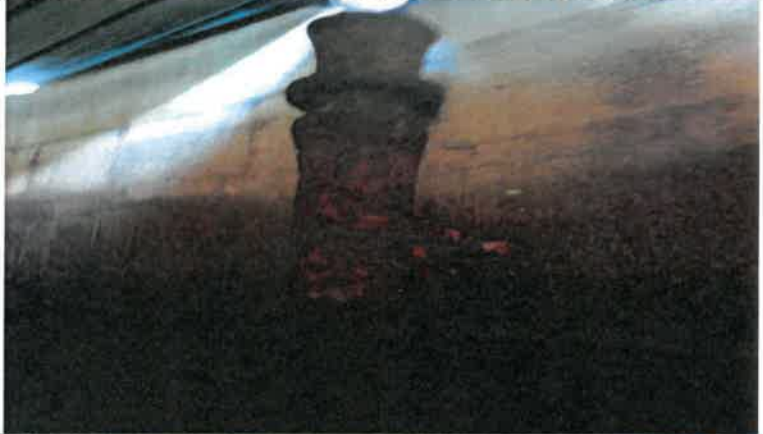
1-5	Valve		
Description:			
External valve has moderate rust at base of connection to reservoir wall.			
Reference:	Component:	ID:

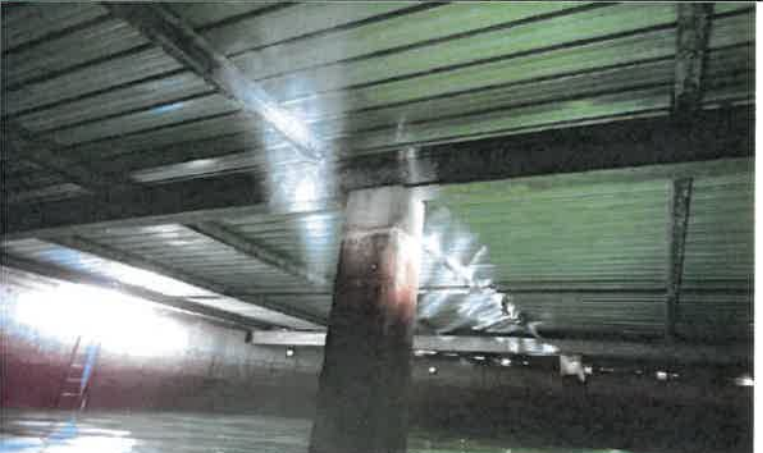
1-7	Roof		
Description:			Gaps in central roof gutter
Central gutter does not filter water away from roof and high rain events will spill over into inside.			
Reference:	Component:	ID:

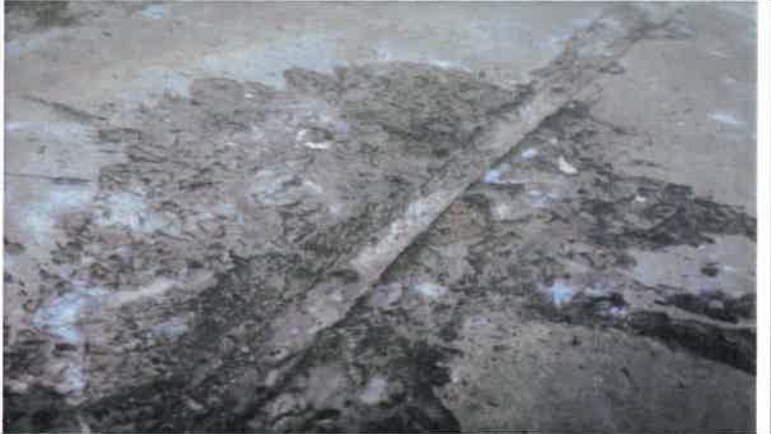
1-9	Walls		
Description:			
<p>Appears to be in moderate condition, exposed aggregate is noticeable on walls with staining in multiple locations.</p>			
Reference:	Component:	ID:
