ARO INDUSTRIES

DON RIVER STREAMBANK GEOTECHNICAL REPORT

<p>Title: Don River Streambank Geotechnical Report</p> <p>Document No: ARO0388</p> <p>Project Director: Rudd Rankine</p> <p>Author: Kelda Ryan</p> <p>Client: Banana Shire Council</p> <p>Client Contact: Antoine Aubin</p> <p>Client Reference: Don River Streambank</p> <p>Purpose: A geotechnical assessment of the site stability and proposed stabilization of Don River Streambank at Kelly's Road, Banana Shire.</p>	<p>ARO Industries Pty Ltd</p> <p>51 Sheridan Street Cairns, QLD, 4870</p> <p>PO Box 6490 Cairns QLD 4870</p> <p>Phone: (07) 4281 6897</p> <p>www.aroindustries.com.au</p>
---	--

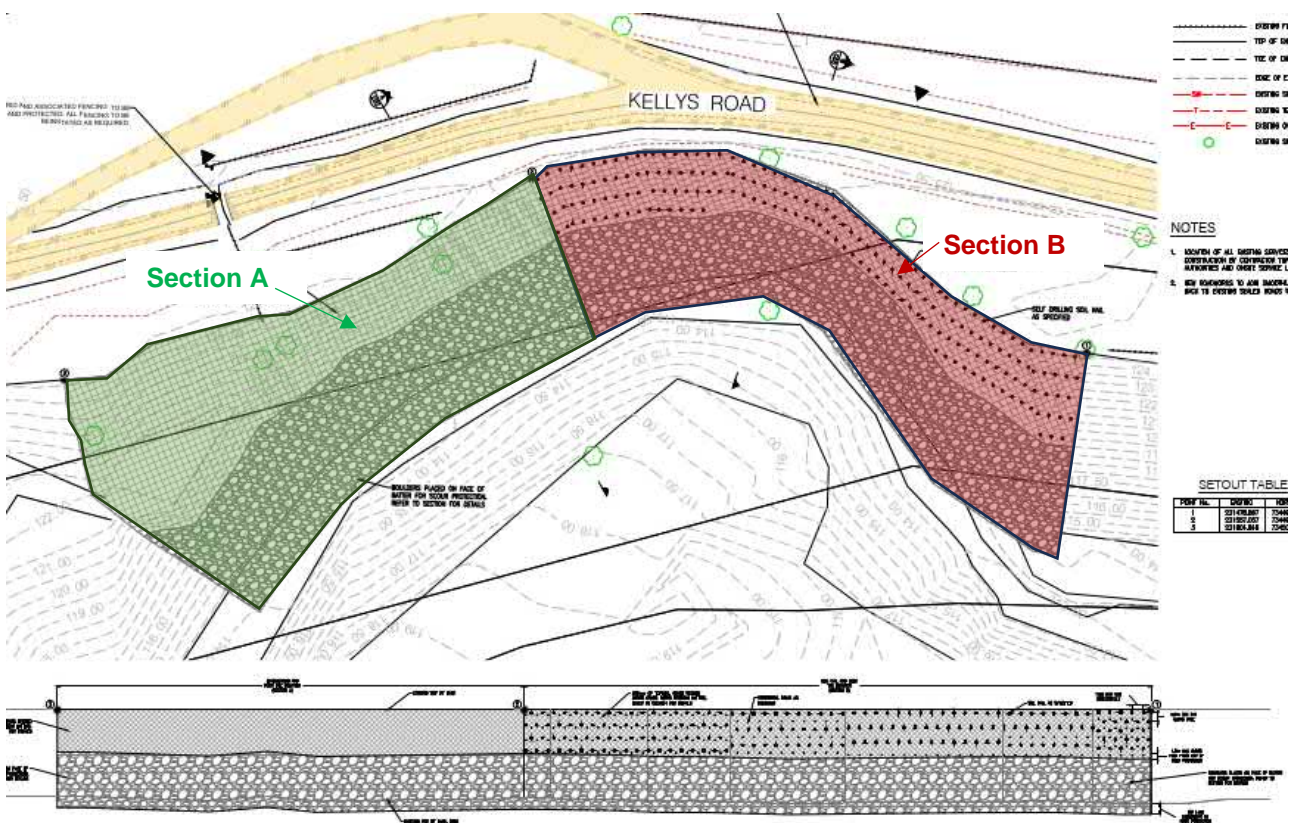
Figure 1: Overall Schematic of bank stabilisation works

It is proposed to stabilise the green shaded portion (Section A), with rock protection at the base of the bank up to approximately 6m in height. The top portion will be revegetated. The red section of the bank (Section B) will have the same rock protection works on the lower portion of the site, but soil nails are recommended to the upper portion of the batter. The soil nails were required in the red Section B, to ensure that the batter stability met factor of safety requirements for dry and saturated conditions.

- Rock protection along the toe of the full length of the failure to a height of 6m,
- Soil nails (12m long) installed in Section B only (*Red Section below).
- Revegetation of the upper portion of the banks (above the rock protection) using locally sourced native species.

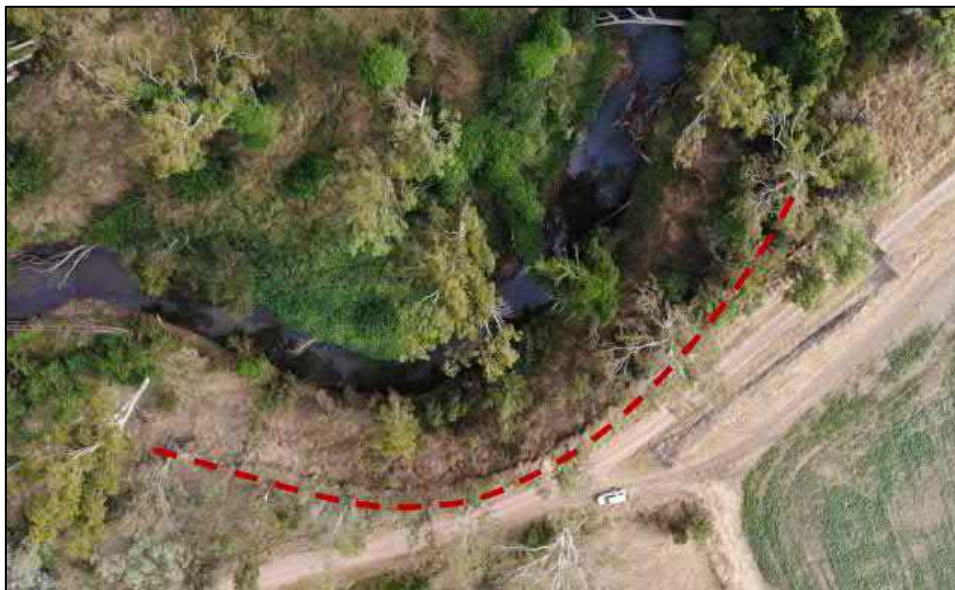
Figure 2 – Plan view of site showing extent of the erosion

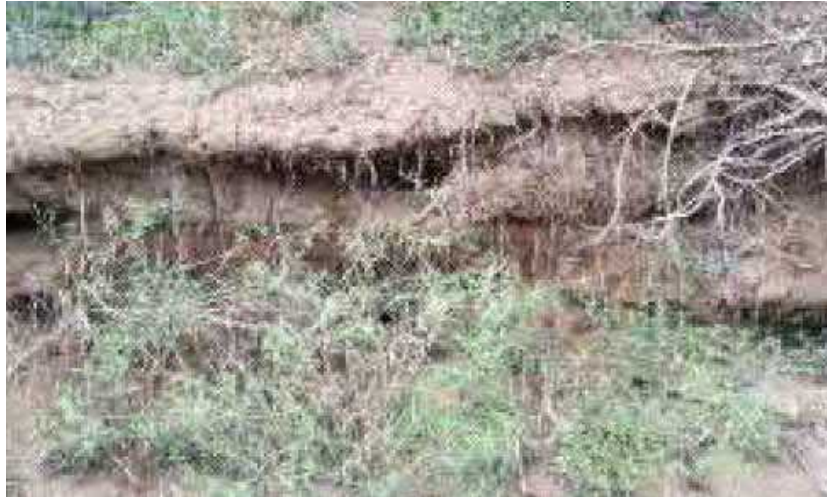
At the request of Orion Project Consulting (Orion) ARO Industries Pty Ltd (ARO) has undertaken a geotechnical assessment for the proposed remediation works to the scour damage that occurred along 160m of the Don River Streambank affecting Kellys Road, Dixalea. The scour damage is visible along the toe of the batter indicating potential for instability.

Figure 3 – Active erosion of the toe of the batter

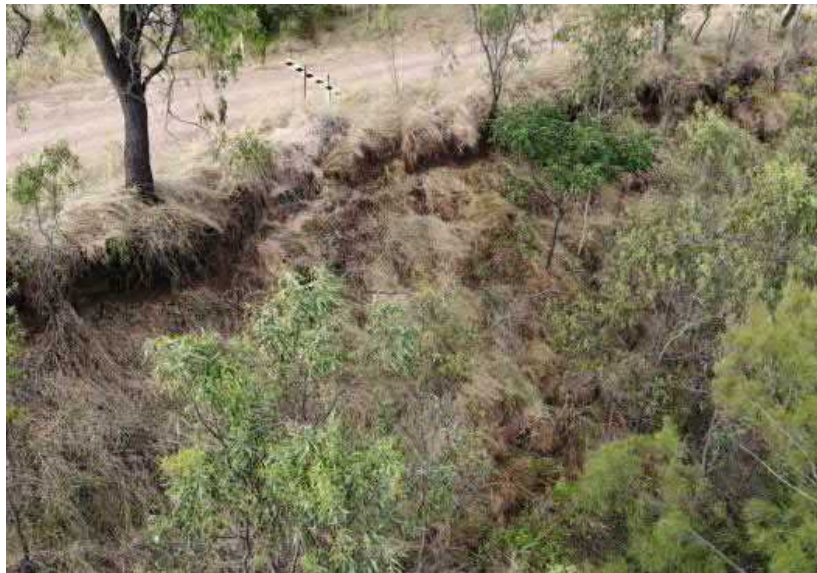
Figure 4 – Photo showing the geotechnical failure of the batter immediately adjacent to Kelly's Road

The results of the stability analyses show that the factors of safety are not within the acceptable limits during both wet and dry conditions. These results indicate instability of the batters which is consistent with the failures observed on site. The site is still considered unstable and requires retention or other remediation works to strengthen and stabilise the batters to achieve the required factor of safety. These may include:

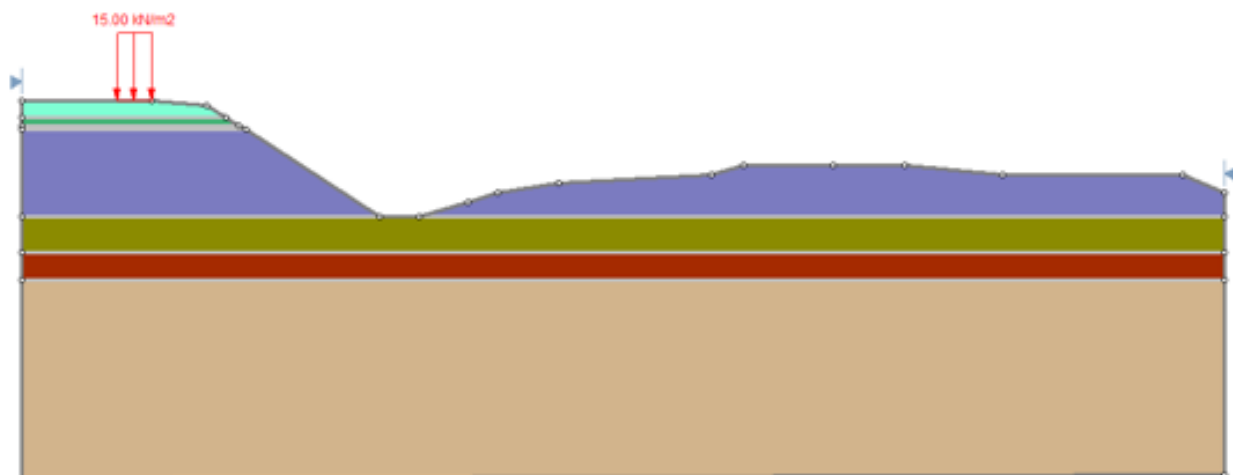
Figure 12 – Section A-A' with interpreted ground conditions based on report provided by Douglas Partners

Site	Calculated Factor of Safety ⁵		
	Dry Conditions	Wet Conditions	
		Undrained	Drained (Steady State Groundwater)
A-A'	<1.5	>1.2	<1.2
B-B'	<1.5	>1.2	<1.2

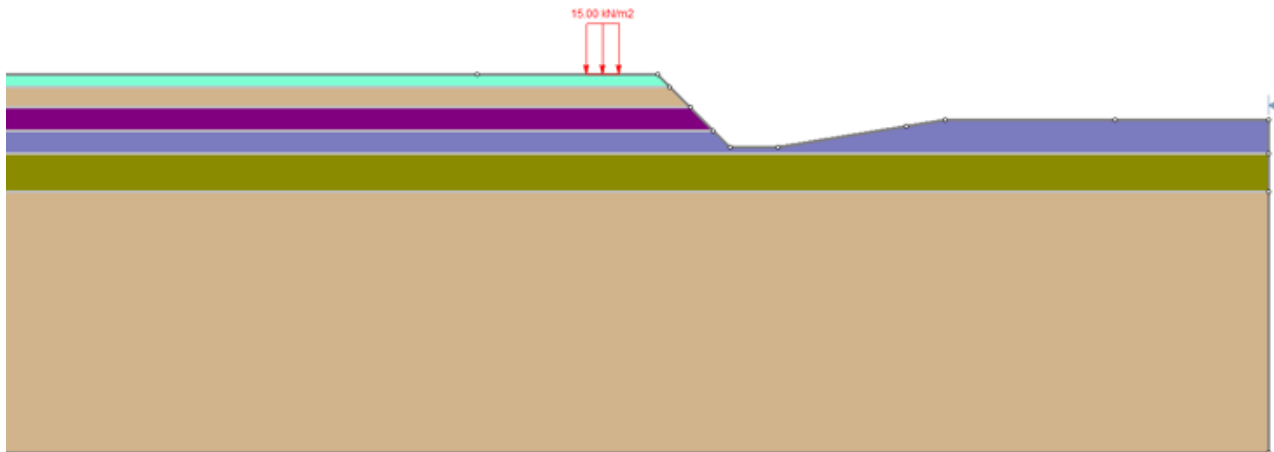
Figure 13 – Section B-B' with interpreted ground conditions based on report provided by Douglas Partners

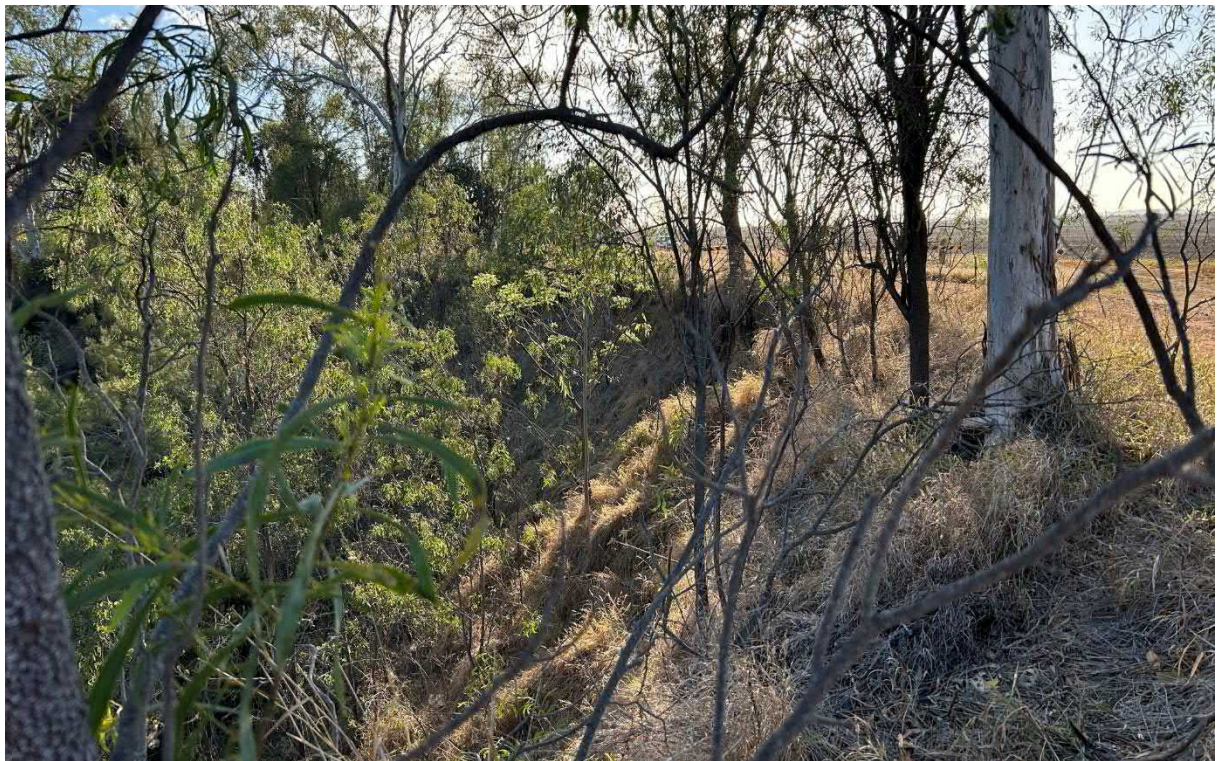
The riverbank (backscarp of streambank failure) was very steep and estimated to be approximately 15 m in height. The crest of the riverbank was relatively flat and level, covered with grass and vegetated with mature gum trees. The existing unsealed gravel road (Kellys Road) was setback between 2 m and 20 m from the crest of the riverbank. Photographs of typical site conditions at the time of investigation are shown in Figures 1.

Figure 2: View of riverbank failure
