# Geotechnical Investigation

Proposed Splash Park

Lions Park - Lot 10 on B74477

**Report Number:** J002010-002-R-Rev0

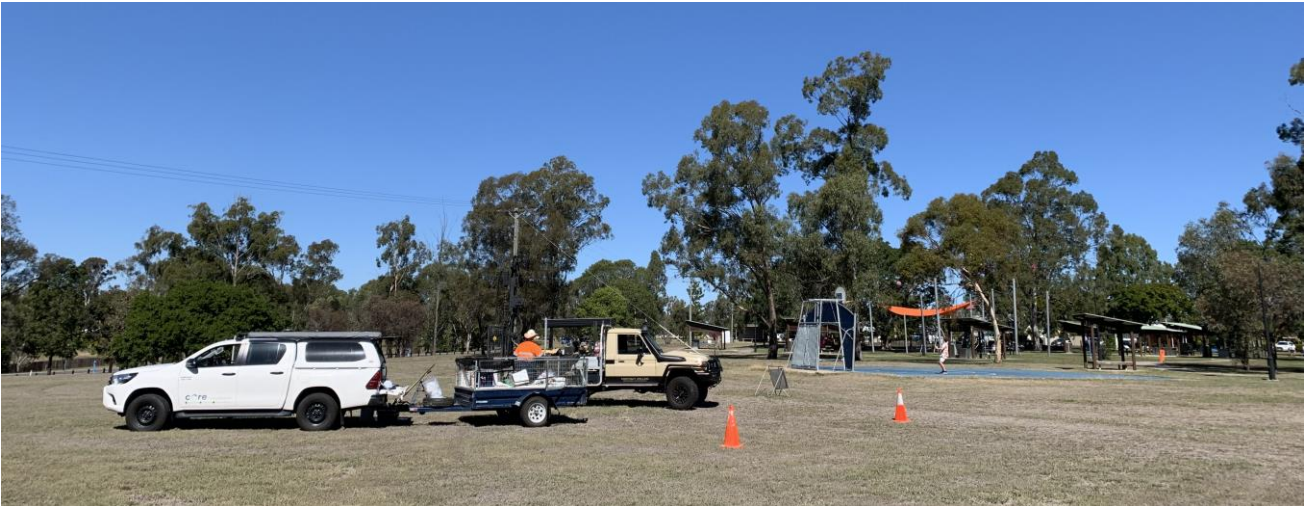
**Photograph 1: Looking south towards borehole BH4.**

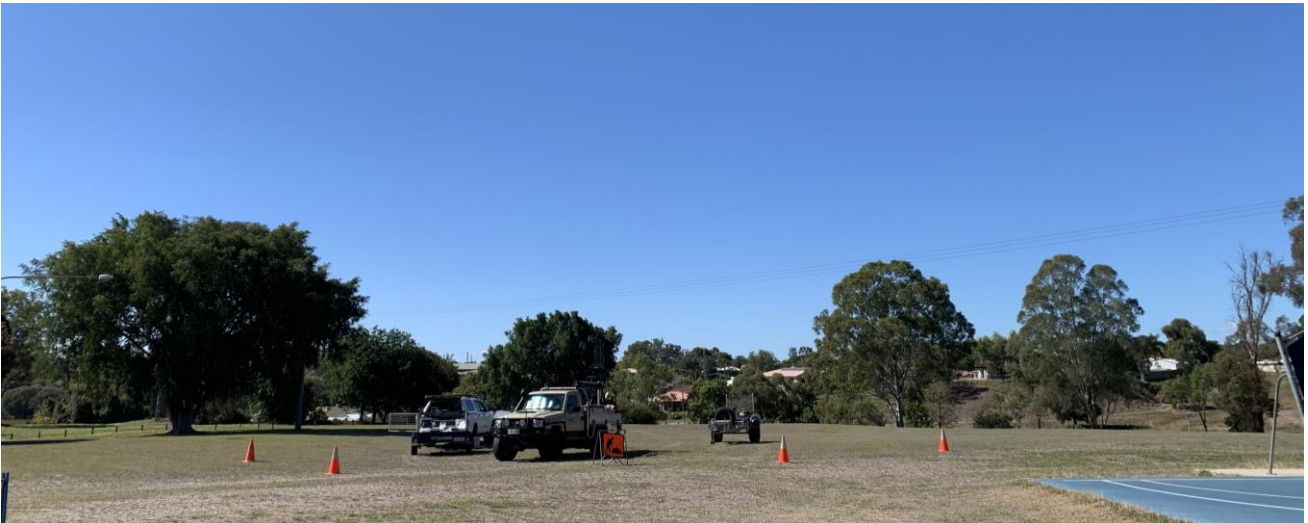
**Photograph 2: Looking north towards borehole BH4.**

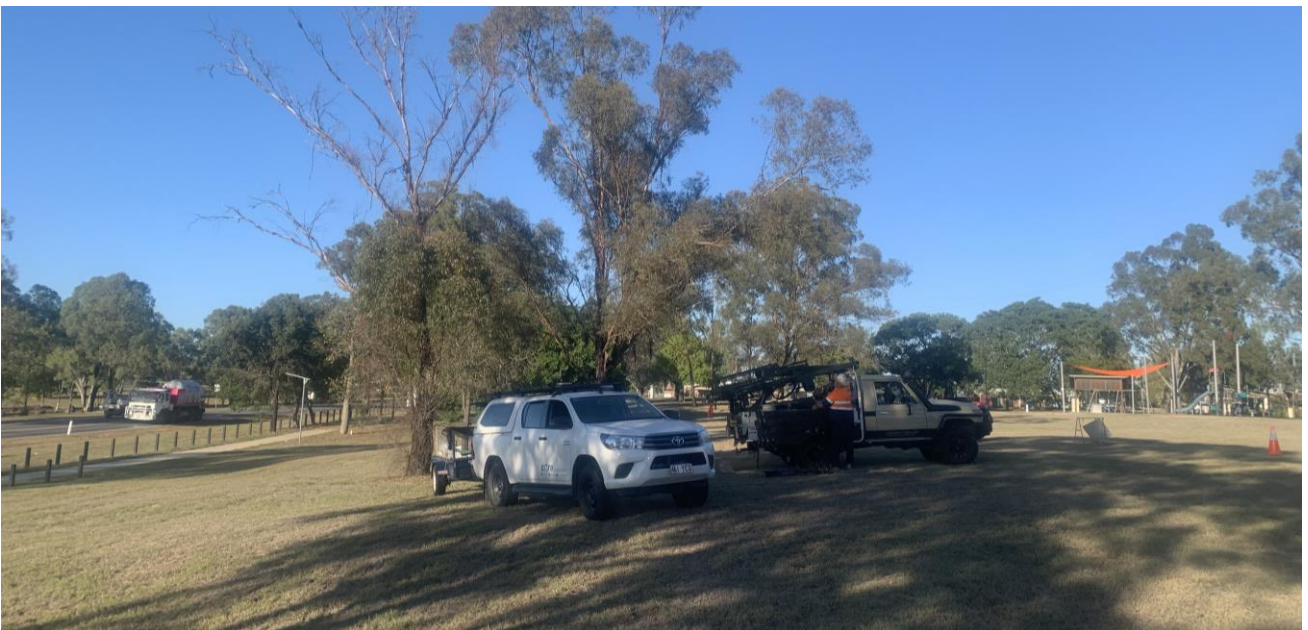
**Photograph 3: Looking south towards borehole BH3.**

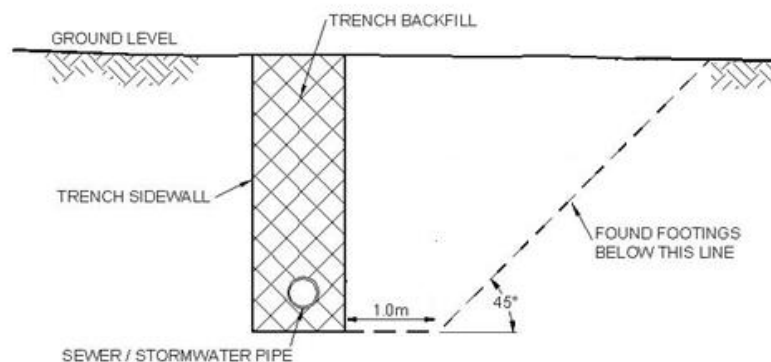
**Diagram 1: Exclusion zone for base of footings**

All footings should be founded such that they are not adversely affected by any adjacent excavations, batter slopes, trenches, or retaining walls that are not designed to support building loads. To minimise the potential for any adverse interaction effects, footings should be founded at least below a plane extending 1 m horizontally from the base of trenches/batter slopes/excavations/retaining walls, then rising up at 1V:1H. This requirement is illustrated in Diagram 1.
