## ASBESTOS MANAGEMENT PLAN

### Biloela Lions Park

**Title:** Biloela Lions Park - Asbestos Management Plan

**Reference:** 173107\_AMP\_MC\_111124

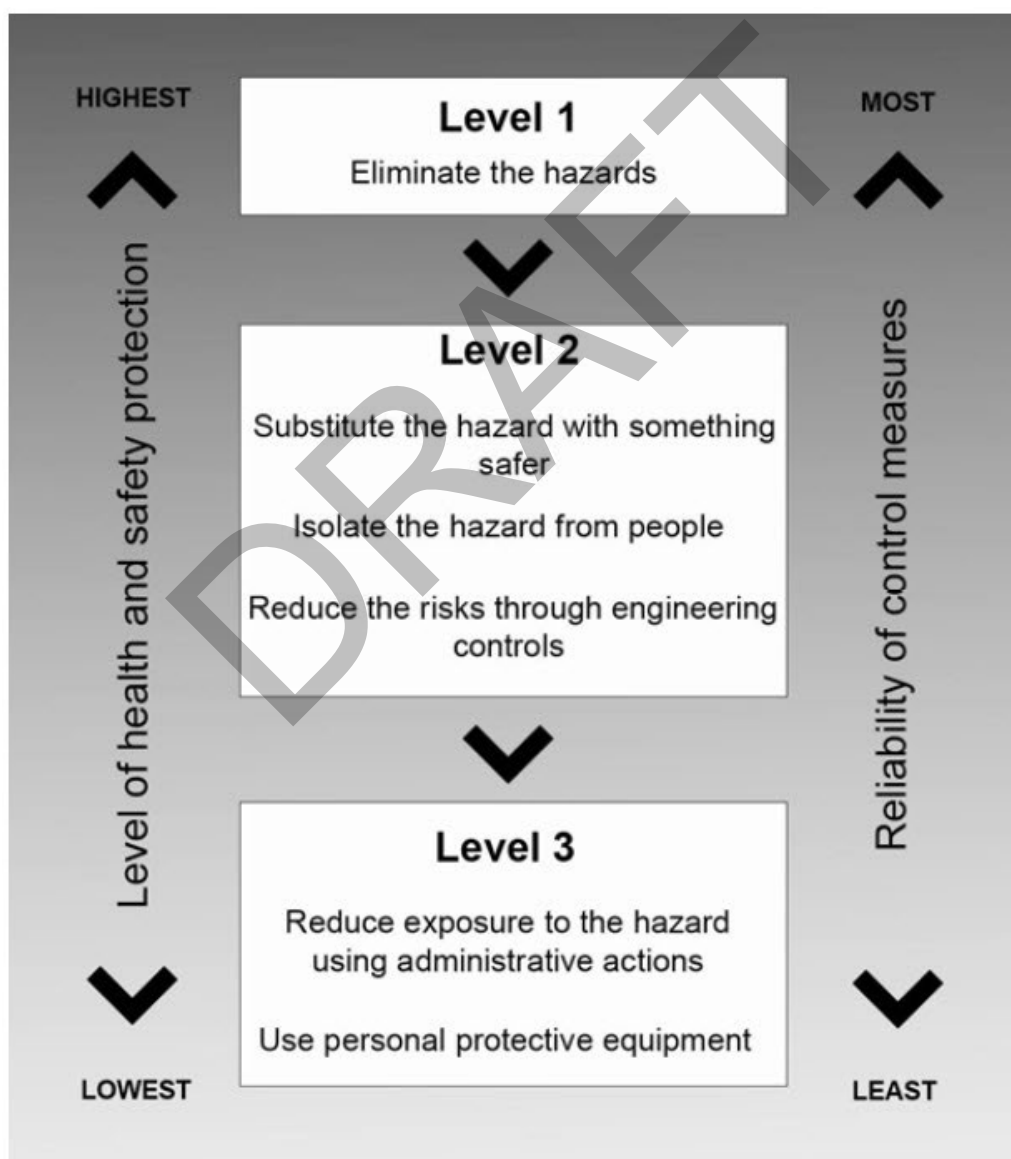
**Figure 1 – The Hierarchy of Controls**

1. **Elimination** – Complete removal of the hazard
2. **Substitution and process modification** - controlling the hazard at source or replacing one substance or activity with a less hazardous one.
3. **Isolation** – Isolate the hazard from people.
4. **Engineering controls** – isolation, enclosure or sealing.
5. **Administrative controls** - responsibilities, site inductions and policies, awareness and training, control procedures, procedures for safe work practices, reporting and record keeping; and
6. **Personal protective equipment (PPE)** for residual risk which cannot be adequately controlled as above; or when the risk is difficult to quantify.
