Shepherdsons Road Rehabilitation

Factual Report

SHEPHERDSONS ROAD REHABILITATION PROJECT

Job No. NQL2023-0036 | Version 0

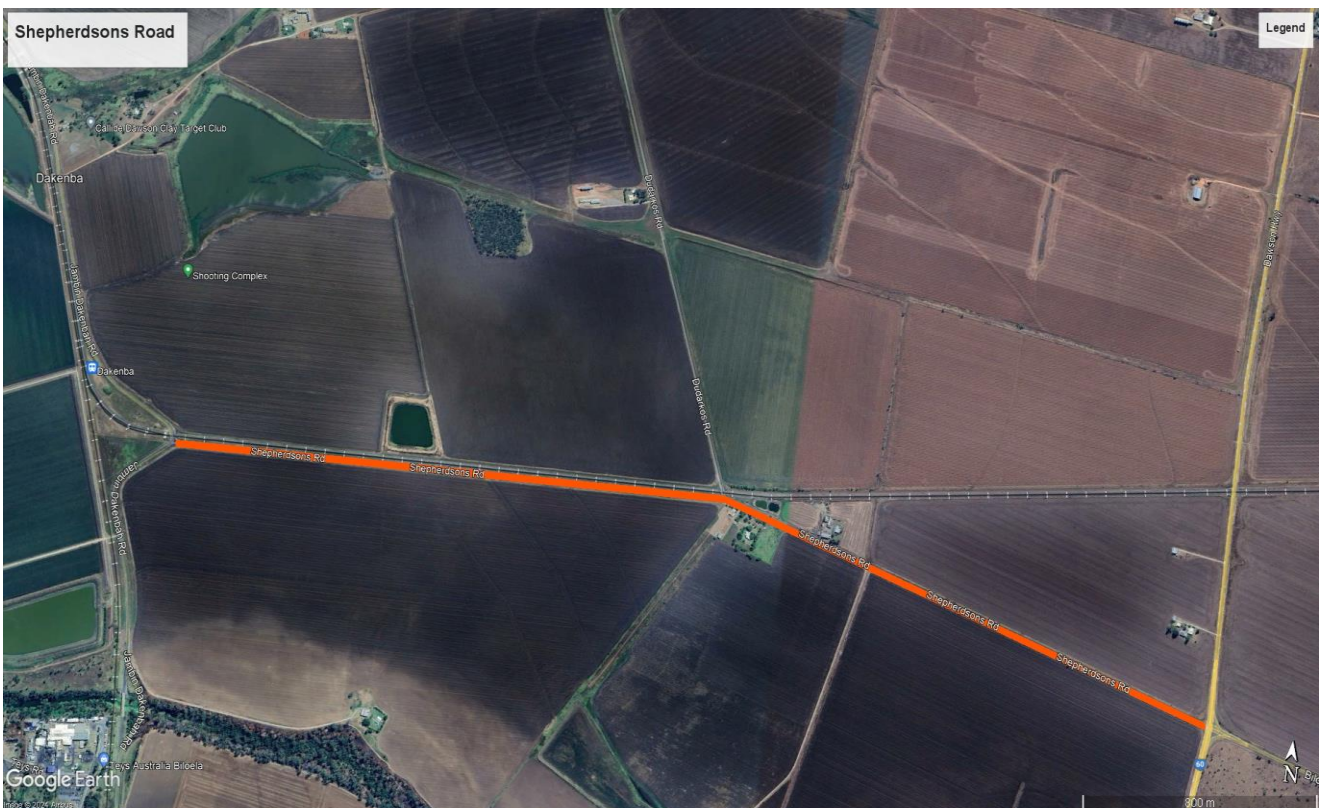
Figure 1: Site Location Plan

The project comprises of rehabilitation of the Shepherds Road with an approximate length of four (04) kilometres. Proposed Shepherds Road for rehabilitation is highlighted in orange colour in Figure 1.

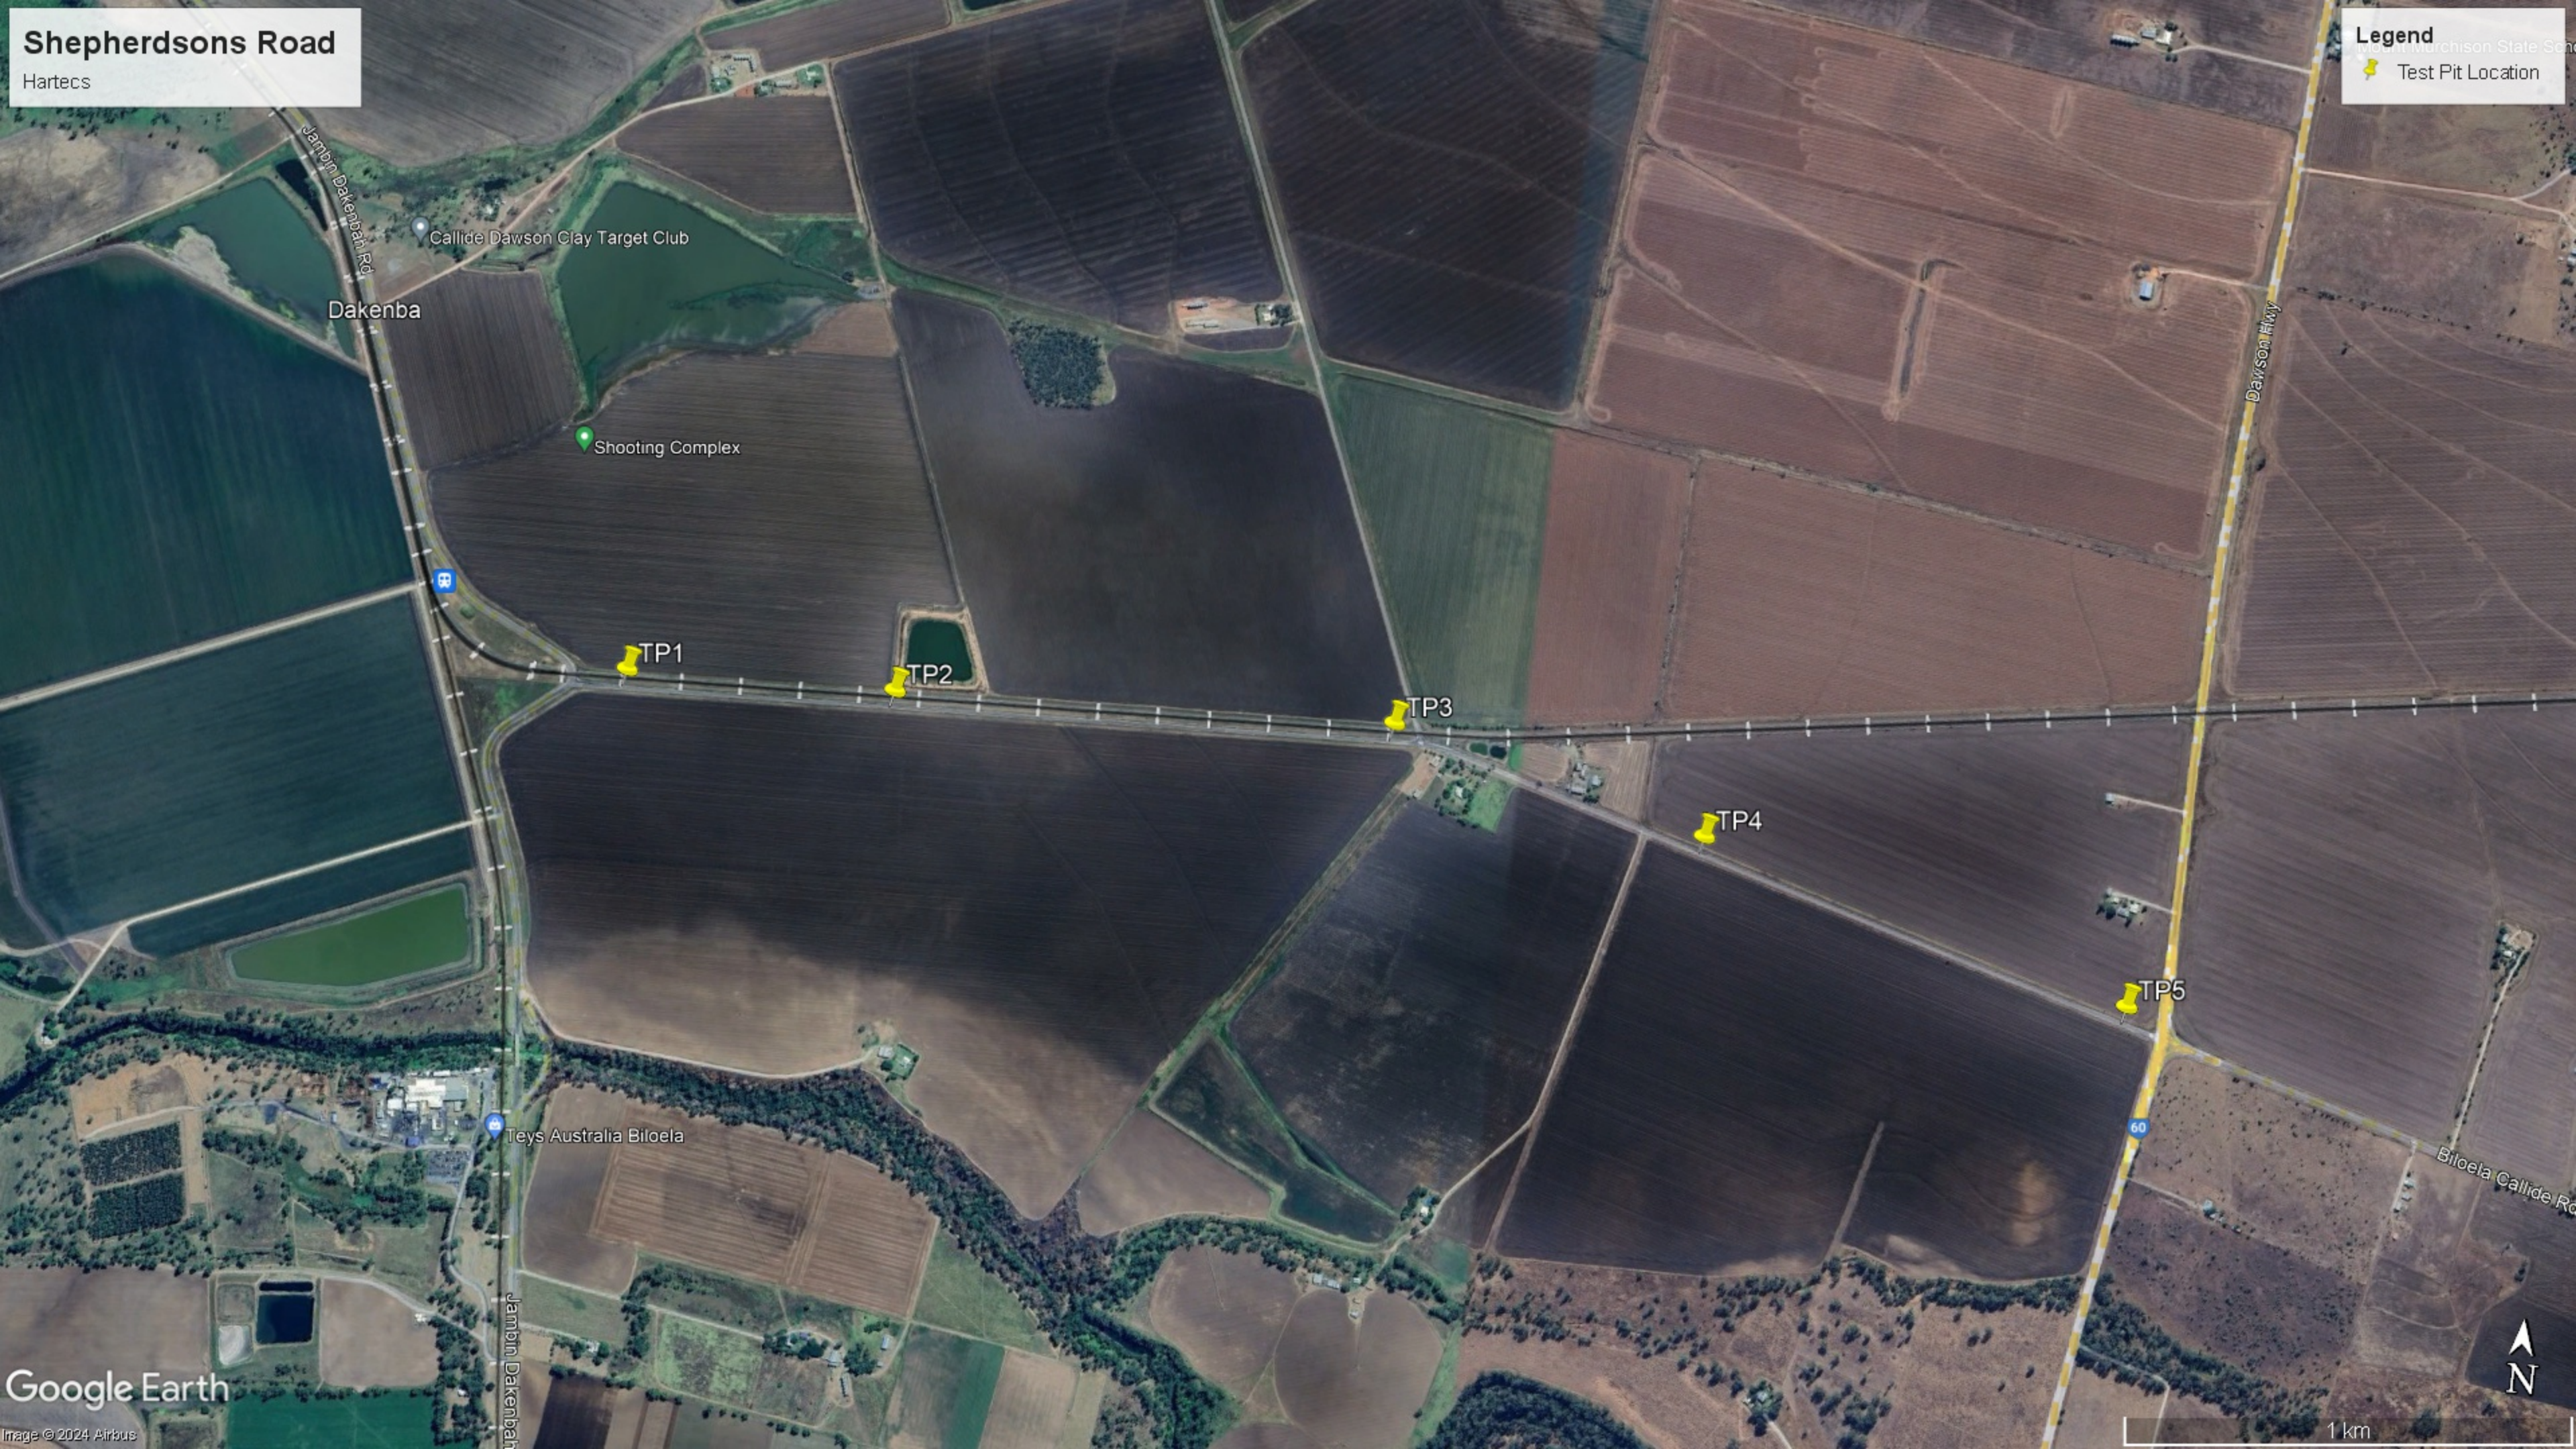
Site Plans

Engineering logs of the subsurface conditions are presented in Appendix B. The locations of the respective sites referred to above are shown in Appendix A.

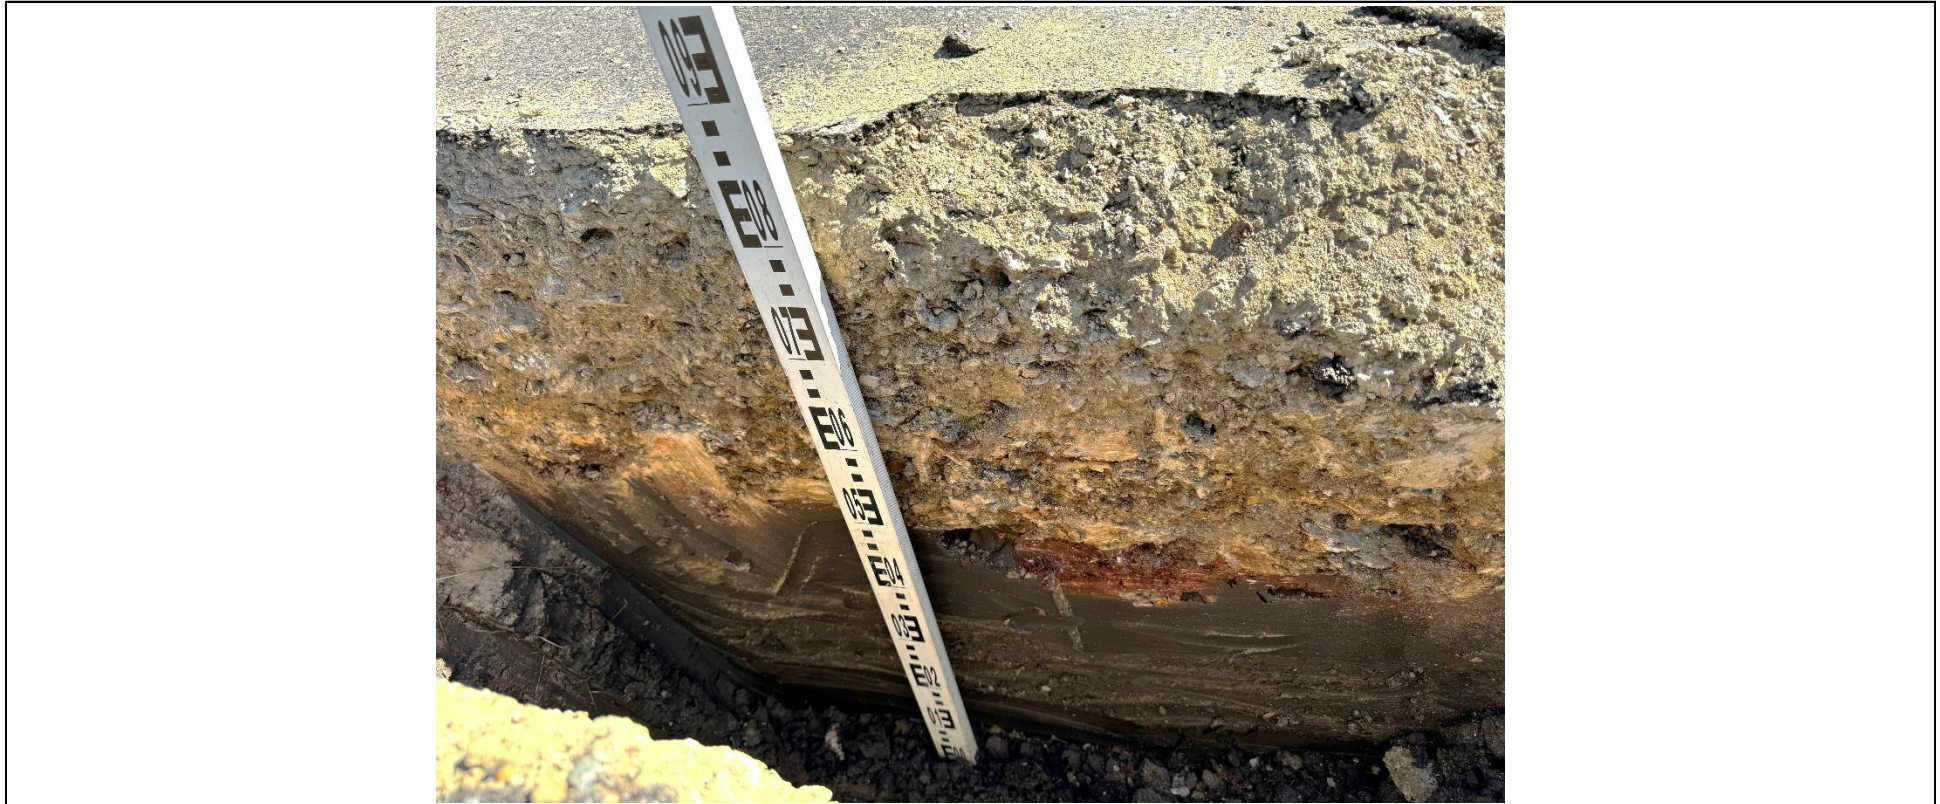
TESTPIT PHOTO: TP-01 – TEST PIT PROFILE

0.0 - 0.3	1 B				GM: Sandy GRAVEL: fine to coarse grained gravel, sub-angular to angular, pale brown, fine to medium grained sand, with low plasticity silt. (Fill)	M

0.0 - 0.3	2 D										
	0.3 - 0.4	3 B				SP: Clayey Gravelly SAND: fine to coarse grained, pale red mottled orange, fine to medium grained gravel, sub-angular to angular, low plasticity clay, (Fill) CH: CLAY: high plasticity, black, trace sand, fine to medium grained, trace gravel. (Natural)		VD	14

0.3 - 0.4	4 D								4		
	0.4 - 0.9	5 B						<PL	St to VSt	4		
	0.4 - 0.9	6 D								5		
	Test pit terminated at 0.86 m								5			
				1					5			
				2					5			
				3					5

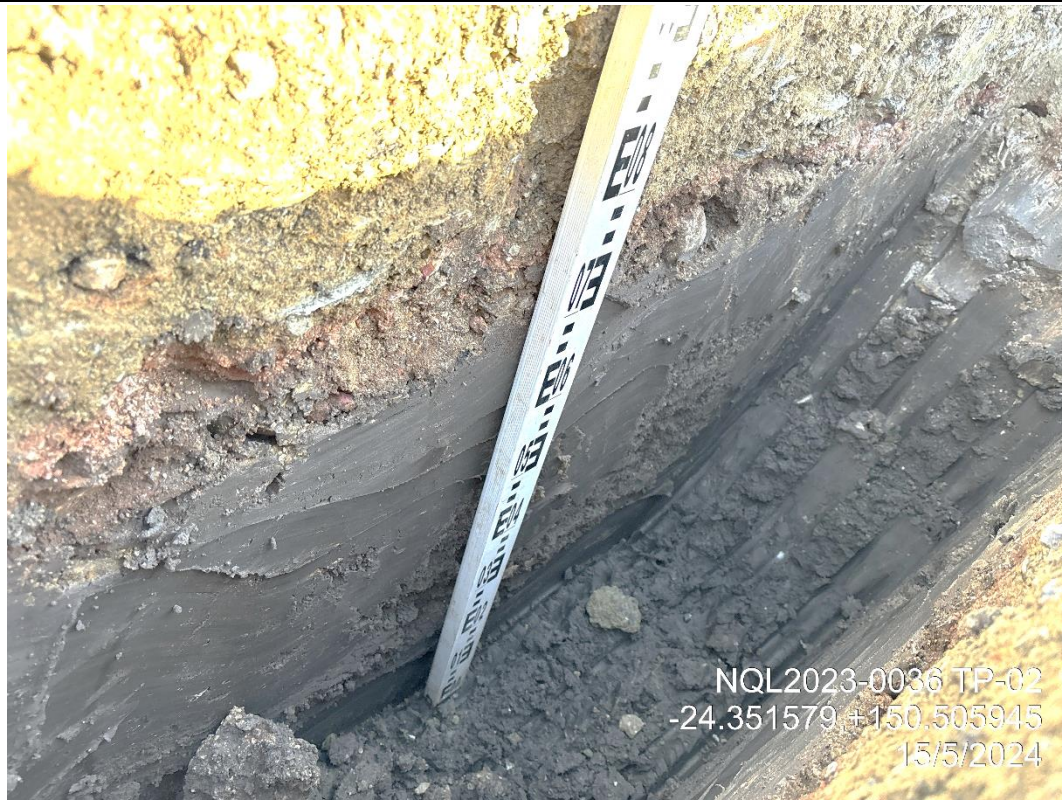
TESTPIT PHOTO: TP-02 – TEST PIT PROFILE

0.0 - 0.3	1 B				Road Surface Seal:	M	VD				
	0.0 - 0.3	2 D				GC: Clayey sandy GRAVEL: fine to coarse grained, sub-angular to angular, pale brown, fine to coarse grained sand, with low plasticity clay. (Fill)

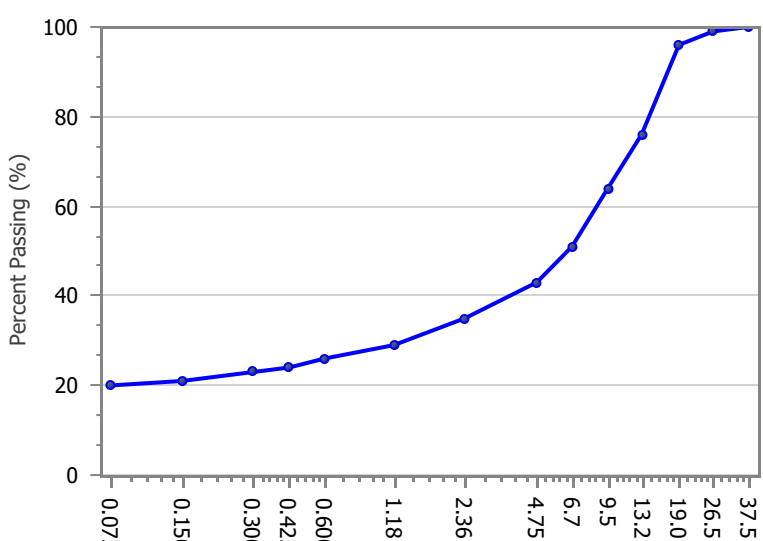
AS Sieve (mm)	Specification Minimum (%)	Percent Passing (%)	Specification Maximum (%)	PARTICLE SIZE DISTRIBUTION GRAPH

37.5		100		
26.5		99		
19.0		96		
13.2		76		
9.5		64		
6.7		51		
4.75		43		
2.36		35		
1.18		29		
0.600		26		
0.425		24		
0.300		23		
0.150		21		
0.075		20

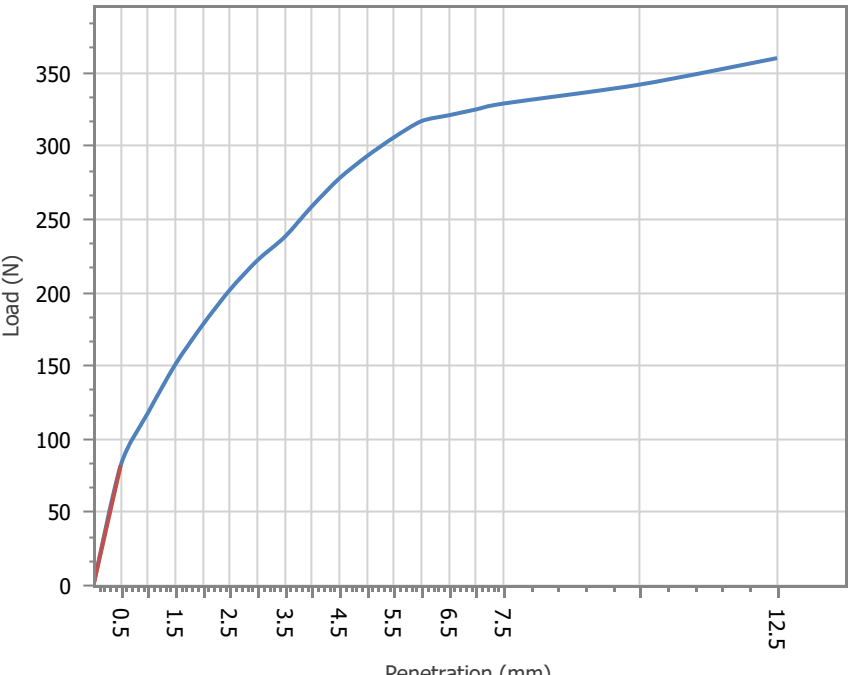
<table style="width: 100%;"> <tr><td>Maximum Dry Density (t/m³):</td><td style="text-align: right;">1.52</td></tr> <tr><td>Optimum Moisture Content (%):</td><td style="text-align: right;">22.0</td></tr> <tr><td>Field Moisture Content (%):</td><td style="text-align: right;">19.1</td></tr> <tr><td>Sample Percent Oversize (%):</td><td style="text-align: right;">0.0</td></tr> <tr><td>Oversize Included / Excluded</td><td style="text-align: right;">Excluded</td></tr> <tr><td>Target Density Ratio (%):</td><td style="text-align: right;">95</td></tr> <tr><td>Target Moisture Ratio (%):</td><td style="text-align: right;">100</td></tr> <tr><td>Placement Dry Density (t/m³):</td><td style="text-align: right;">1.44</td></tr> <tr><td>Placement Dry Density Ratio (%):</td><td style="text-align: right;">95.0</td></tr> <tr><td>Placement Moisture Content (%):</td><td style="text-align: right;">22.0</td></tr> <tr><td>Placement Moisture Ratio (%):</td><td style="text-align: right;">99.5</td></tr> <tr><td>Test Condition / Soaking Period:</td><td style="text-align: right;">Soaked / 4 Days</td></tr> <tr><td>CBR Surcharge (kg)</td><td style="text-align: right;">4.5</td></tr> <tr><td>Dry Density After Soak (t/m³):</td><td style="text-align: right;">1.44</td></tr> <tr><td>Total Curing Time (hrs)</td><td style="text-align: right;">2</td></tr> <tr><td>Liquid Limit Method</td><td style="text-align: right;">Estimation</td></tr> <tr><td>Moisture (top 30mm) After Soak (%)</td><td style="text-align: right;">40.1</td></tr> <tr><td>Moisture (remainder) After Soak (%)</td><td style="text-align: right;">33.2</td></tr> <tr><td>CBR Swell (%):</td><td style="text-align: right;">0.0</td></tr> <tr><td>Minimum CBR Specification (%):</td><td style="text-align: right;">-</td></tr> <tr><td>CBR Value @ 5.0mm (%):</td><td style="text-align: right;">1.5</td></tr> </table>	Maximum Dry Density (t/m ³):	1.52	Optimum Moisture Content (%):	22.0	Field Moisture Content (%):	19.1	Sample Percent Oversize (%):	0.0	Oversize Included / Excluded	Excluded	Target Density Ratio (%):	95	Target Moisture Ratio (%):	100	Placement Dry Density (t/m ³):	1.44	Placement Dry Density Ratio (%):	95.0	Placement Moisture Content (%):	22.0	Placement Moisture Ratio (%):	99.5	Test Condition / Soaking Period:	Soaked / 4 Days	CBR Surcharge (kg)	4.5	Dry Density After Soak (t/m ³):	1.44	Total Curing Time (hrs)	2	Liquid Limit Method	Estimation	Moisture (top 30mm) After Soak (%)	40.1	Moisture (remainder) After Soak (%)	33.2	CBR Swell (%):	0.0	Minimum CBR Specification (%):	-	CBR Value @ 5.0mm (%):	1.5	<h3>CBR PENETRATION PLOT</h3>

<table style="margin-left: auto; margin-right: auto;"> <tr><th>Penetration (mm)</th><th>Load (N)</th></tr> <tr><td>0.5</td><td>~80</td></tr> <tr><td>1.5</td><td>~150</td></tr> <tr><td>2.5</td><td>~200</td></tr> <tr><td>3.5</td><td>~240</td></tr> <tr><td>4.5</td><td>~280</td></tr> <tr><td>5.5</td><td>~310</td></tr> <tr><td>6.5</td><td>~325</td></tr> <tr><td>7.5</td><td>~335</td></tr> <tr><td>12.5</td><td>~360</td></tr> </table>	Penetration (mm)	Load (N)	0.5	~80	1.5	~150	2.5	~200	3.5	~240	4.5	~280	5.5	~310	6.5	~325	7.5	~335	12.5	~360

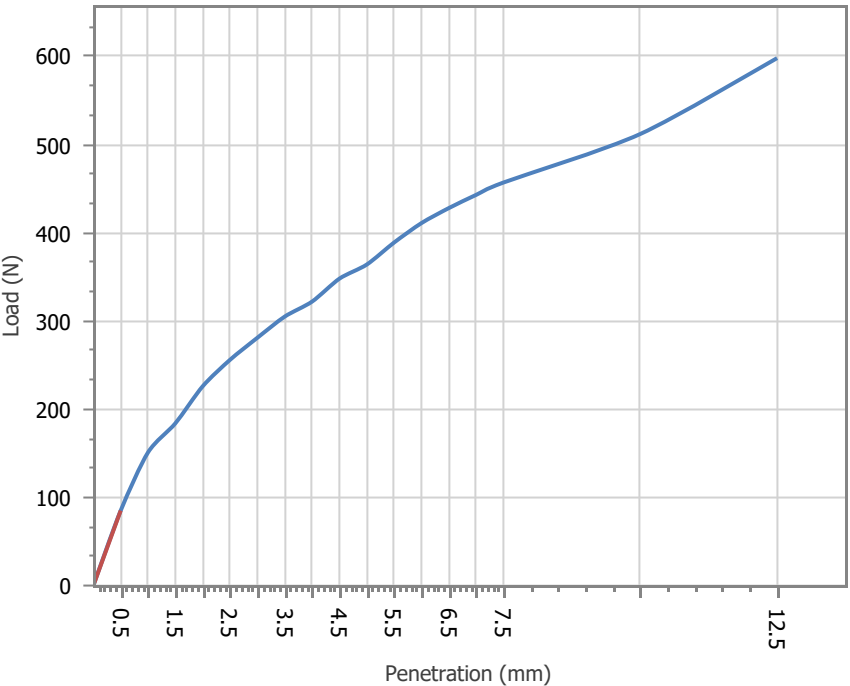
Maximum Dry Density (t/m ³):	1.48	Optimum Moisture Content (%):	22.0	Field Moisture Content (%):	16.7	Sample Percent Oversize (%):	0.0	Oversize Included / Excluded	Excluded	Target Density Ratio (%):	95	Target Moisture Ratio (%):	100	Placement Dry Density (t/m ³):	1.41	Placement Dry Density Ratio (%):	95.0	Placement Moisture Content (%):	22.0	Placement Moisture Ratio (%):	99.5	Test Condition / Soaking Period:	Soaked / 4 Days	CBR Surcharge (kg)	-	Dry Density After Soak (t/m ³):	1.33	Total Curing Time (hrs)	4	Liquid Limit Method	Estimation	Moisture (top 30mm) After Soak (%)	38.3	Moisture (remainder) After Soak (%)	33.8	CBR Swell (%):	6.0	Minimum CBR Specification (%):	-	CBR Value @ 2.5mm (%):	2.0	<div style="text-align: center;"> <h3>CBR PENETRATION PLOT</h3>

</div>
Maximum Dry Density (t/m ³):	1.48																																										
Optimum Moisture Content (%):	22.0																																										
Field Moisture Content (%):	16.7																																										
Sample Percent Oversize (%):	0.0																																										
Oversize Included / Excluded	Excluded																																										
Target Density Ratio (%):	95																																										
Target Moisture Ratio (%):	100																																										
Placement Dry Density (t/m ³):	1.41																																										
Placement Dry Density Ratio (%):	95.0																																										
Placement Moisture Content (%):	22.0																																										
Placement Moisture Ratio (%):	99.5																																										
Test Condition / Soaking Period:	Soaked / 4 Days																																										
CBR Surcharge (kg)	-																																										
Dry Density After Soak (t/m ³):	1.33																																										
Total Curing Time (hrs)	4																																										
Liquid Limit Method	Estimation																																										
Moisture (top 30mm) After Soak (%)	38.3																																										
Moisture (remainder) After Soak (%)	33.8																																										
CBR Swell (%):	6.0																																										
Minimum CBR Specification (%):	-																																										
CBR Value @ 2.5mm (%):	2.0
