Memorandum

09 April 2018

To	Banana Shire Council		
Copy to	Ray Geraghty (Chief Executive Officer - Banana Shire Council)		
From	Greg Penhaligon (Senior Civil Engineer - GHD)	Tel	(07) 4973 1600
Subject	Gibihi Road Alternative Access	Job no.	42/20370

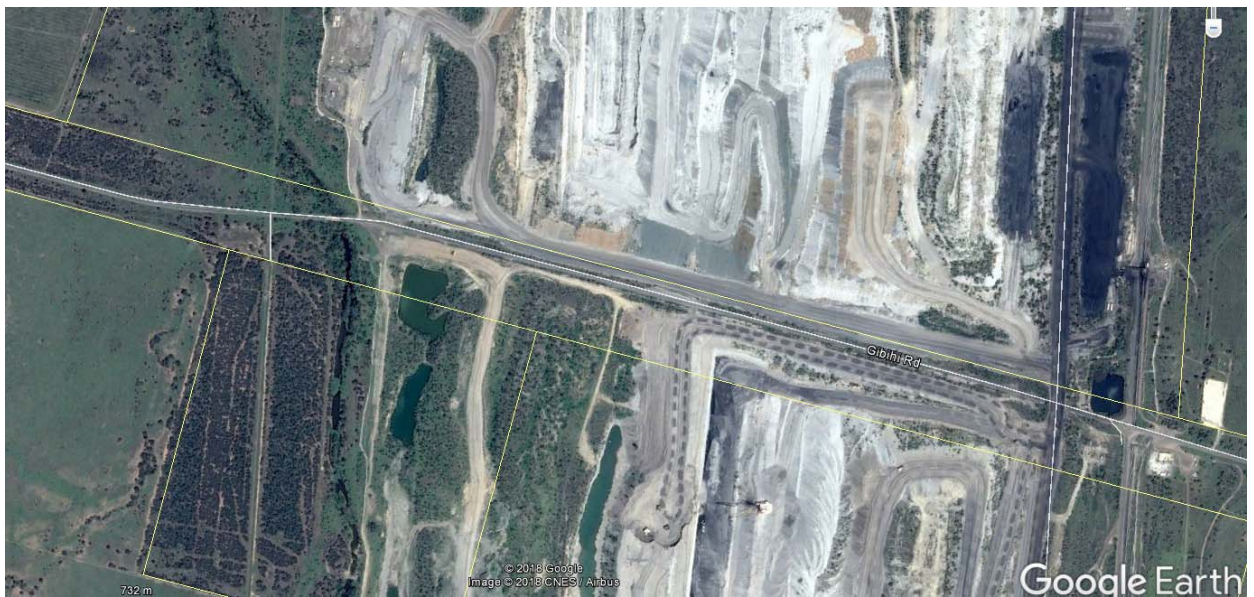
Figure 2 Cadastral Boundaries for the Gibihi Road (Source: Google Earth/Queensland Globe)

Gibihi Road is located in a road reserve crossing the Dawson Mine, the cadastral boundaries of which are indicated in the yellow lines in Figure 2. The Gibihi Road formation is located along the northern side of the reserve, as indicated by the white line. Council has limited rights to build own and operate a new road within the road reserve under the mining lease, but little or no rights outside of the reserve.
