# Geotechnical Investigation

Proposed Splash Park

Lions Park - Lot 10 on B74477

**Report Number:** J002010-002-R-Rev0

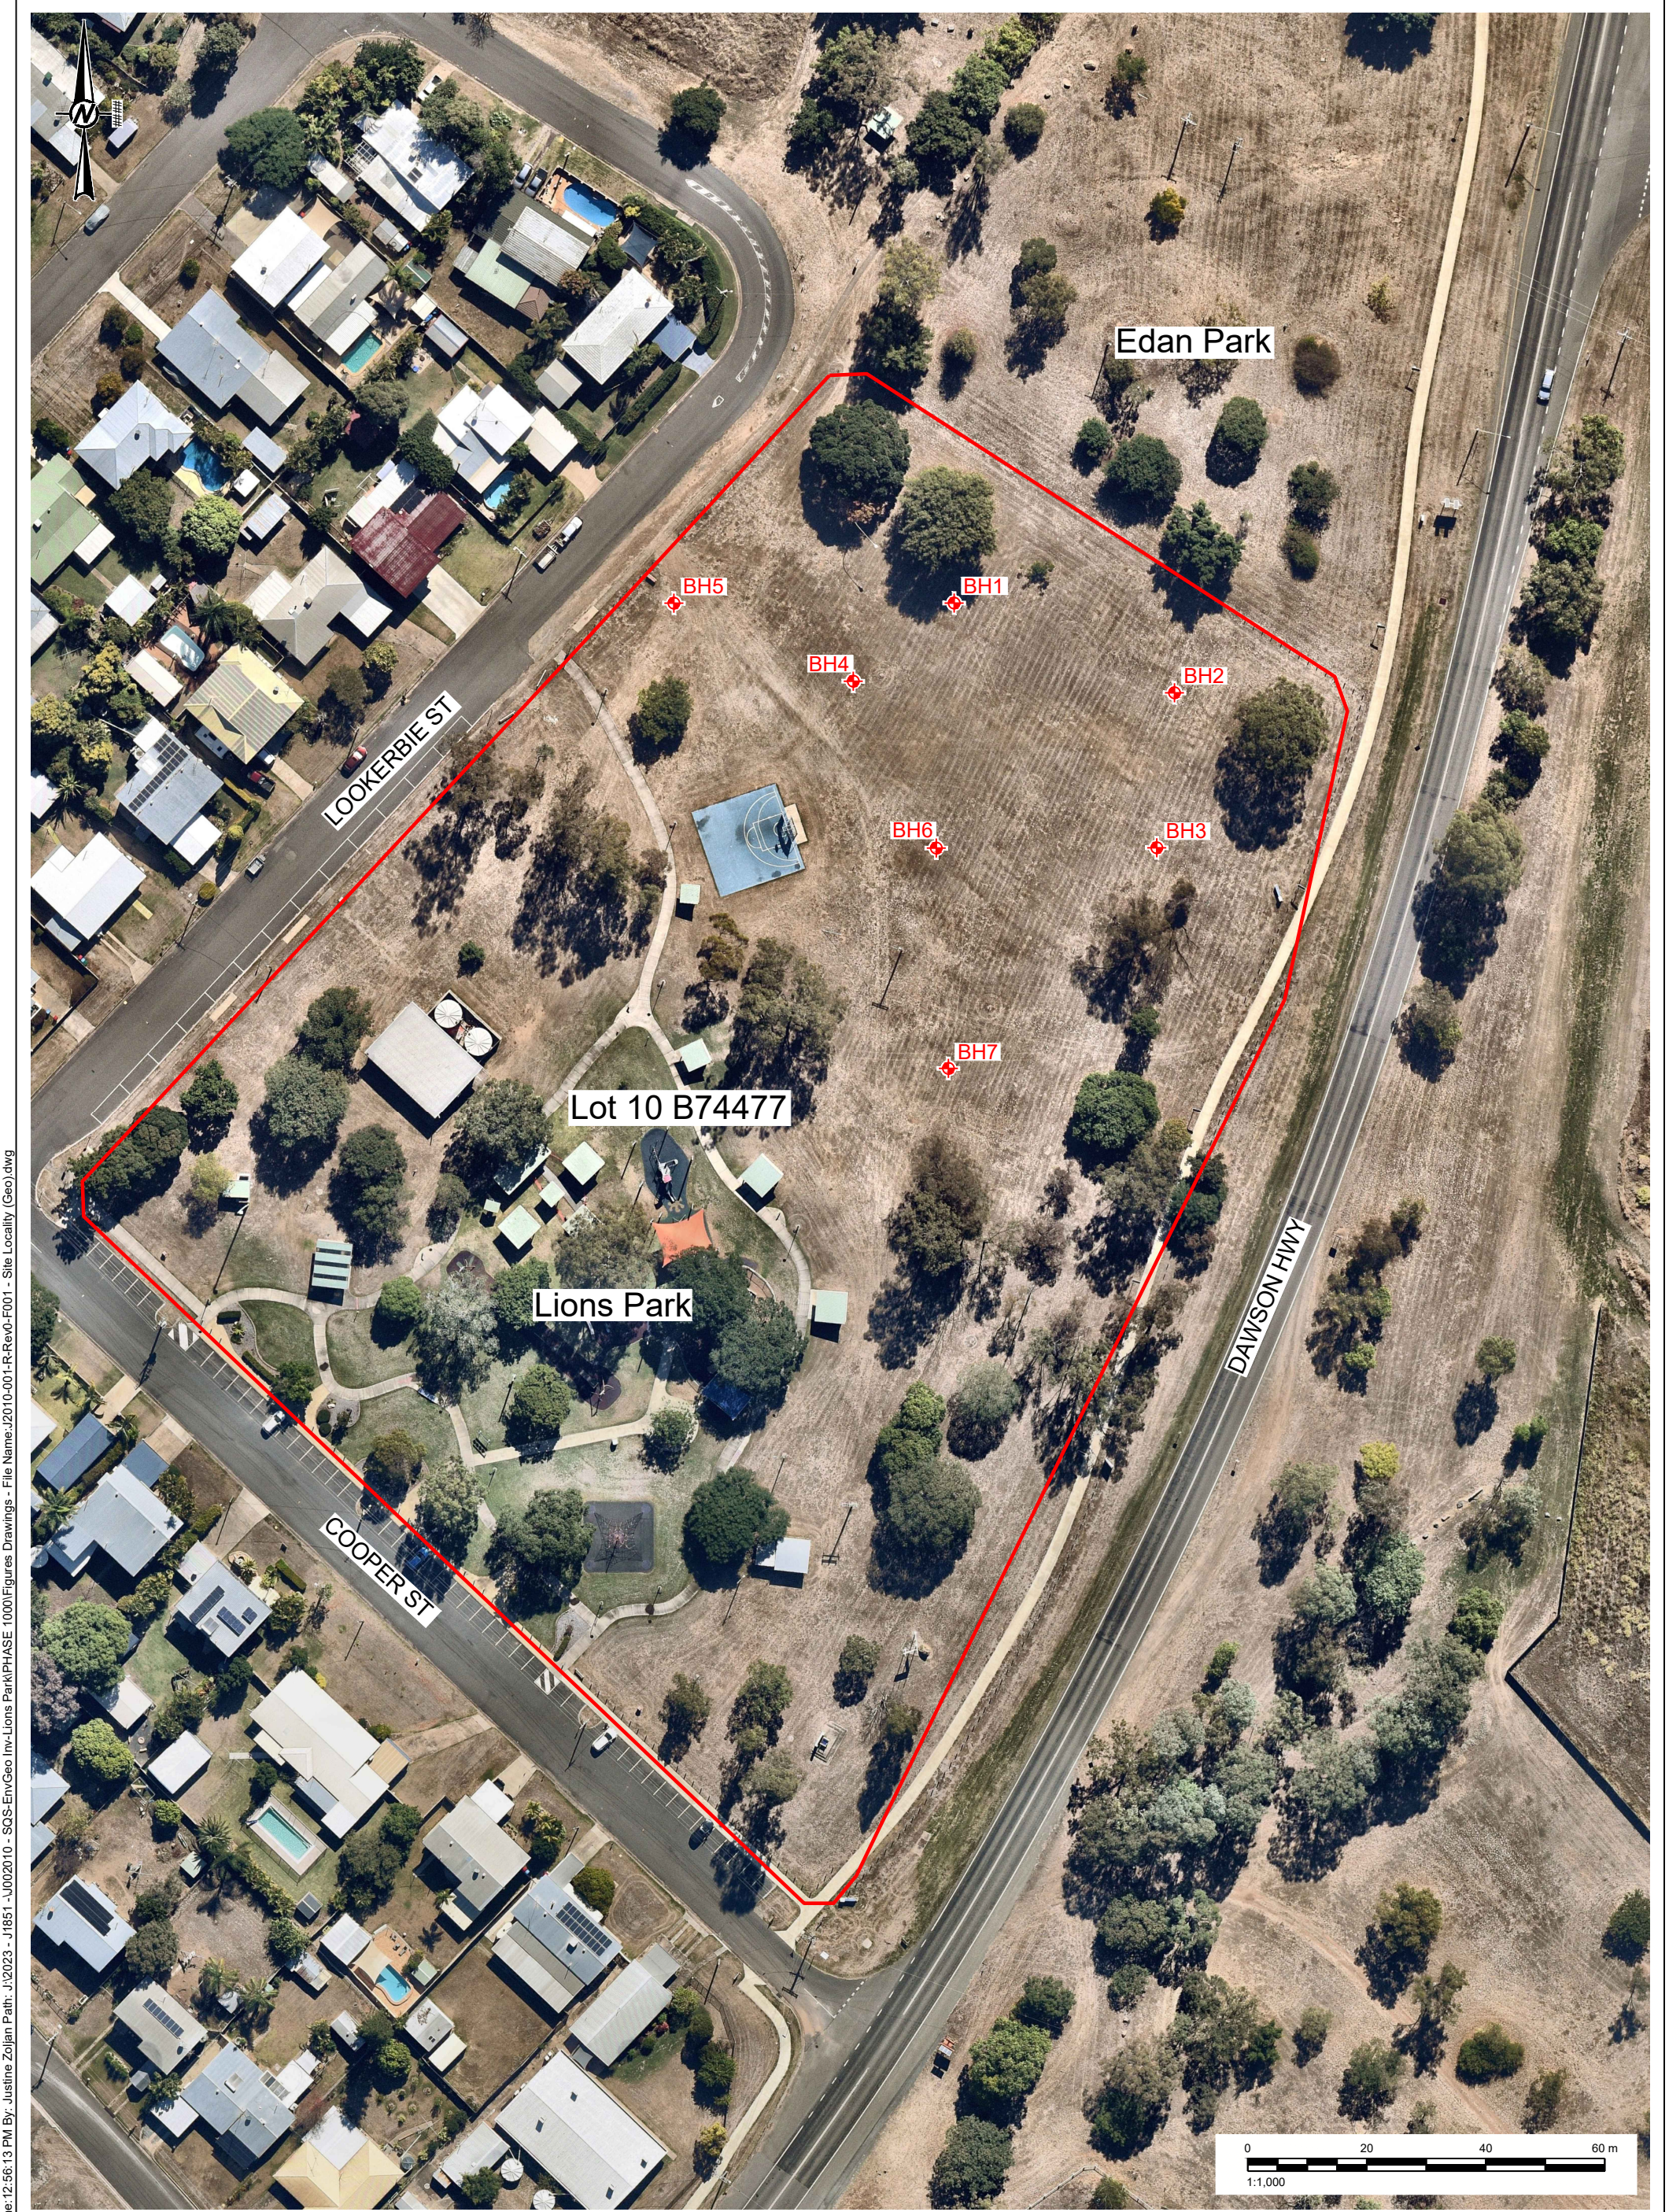
## **Geotechnical Test Location Plan**

Seven boreholes (designated BH1 to BH7) were drilled across the site, approximately at the locations nominated by BSC, as shown on the attached Figure 1 (Appendix A). The boreholes were drilled to depths between 1.5 m and 4.45 m below ground level (BGL).
