ARO INDUSTRIES

DON RIVER STREAMBANK GEOTECHNICAL REPORT

<p>Title: Don River Streambank Geotechnical Report</p> <p>Document No: ARO0388</p> <p>Project Director: Rudd Rankine</p> <p>Author: Kelda Ryan</p> <p>Client: Banana Shire Council</p> <p>Client Contact: Antoine Aubin</p> <p>Client Reference: Don River Streambank</p> <p>Purpose: A geotechnical assessment of the site stability and proposed stabilization of Don River Streambank at Kelly's Road, Banana Shire.</p>	<p>ARO Industries Pty Ltd</p> <p>51 Sheridan Street Cairns, QLD, 4870</p> <p>PO Box 6490 Cairns QLD 4870</p> <p>Phone: (07) 4281 6897</p> <p>www.aroindustries.com.au</p>
---	--

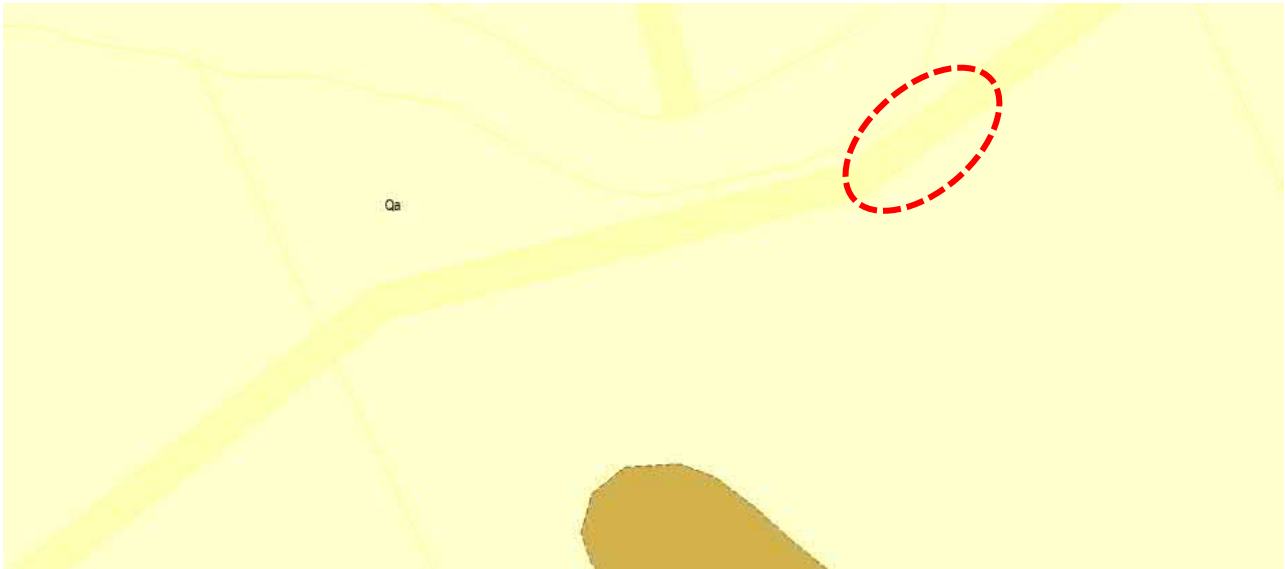
Figure 5 - Geological Survey of Queensland's 1:100,000 Series Map

The Geological Survey of Queensland's detailed surface geology mapping indicates the site is underlain by Quaternary aged floodplain alluvium described as typically comprising "Clay, silt, sand and gravel". The floodplain alluvium is expected to be underlain at depth by Eocene aged Biloela Formation. An extract of the maps from Queensland Globe is shown in Figure 5.

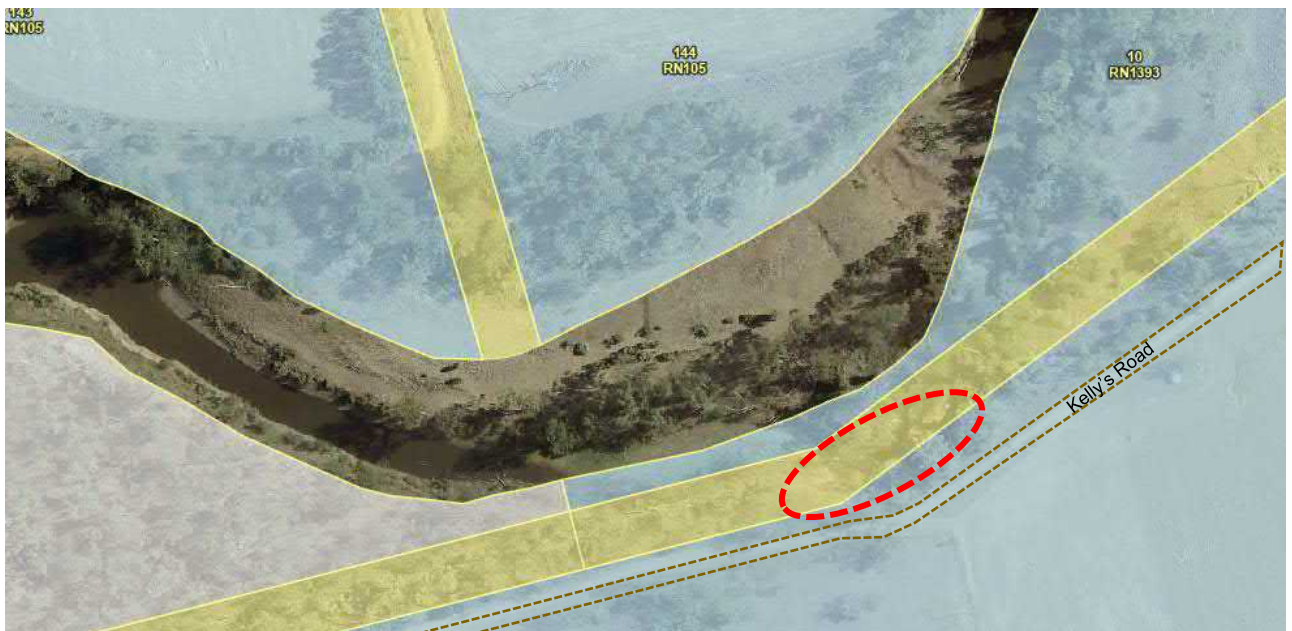
Figure 6 – Tenure of Landslip on Don River Streambank

- Generally, the crest of the slip lies within Lot 10/RN1393 (shaded pale blue) with the batter and toe of the slip in the road reserve (shaded yellow).
- Kelly's Road currently lies outside the perimeter of the council road reserve.
- The location of the landslip is within an existing waterway (Don River).

A cadastral survey is recommended to confirm lot/road reserve boundaries.

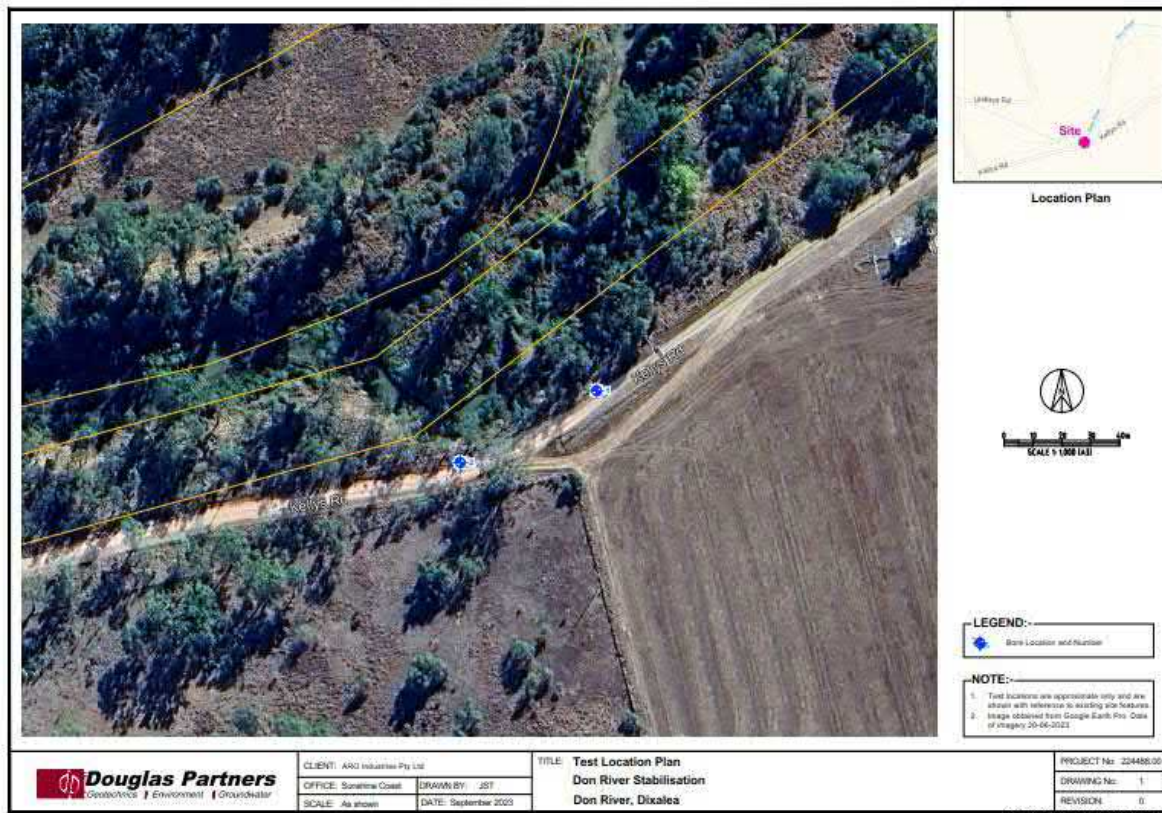
Figure 10 – Test location plan (Douglas Partners)

Based on the conditions encountered at the boreholes the embankment is underlain by at least 20 m of alluvial sediments comprising of interbedded sequences of silty clay, sandy clay, and clayey sandy gravel. Note, rock was not intercepted within the boreholes and the depth of alluvial sediments within the profile is not known.

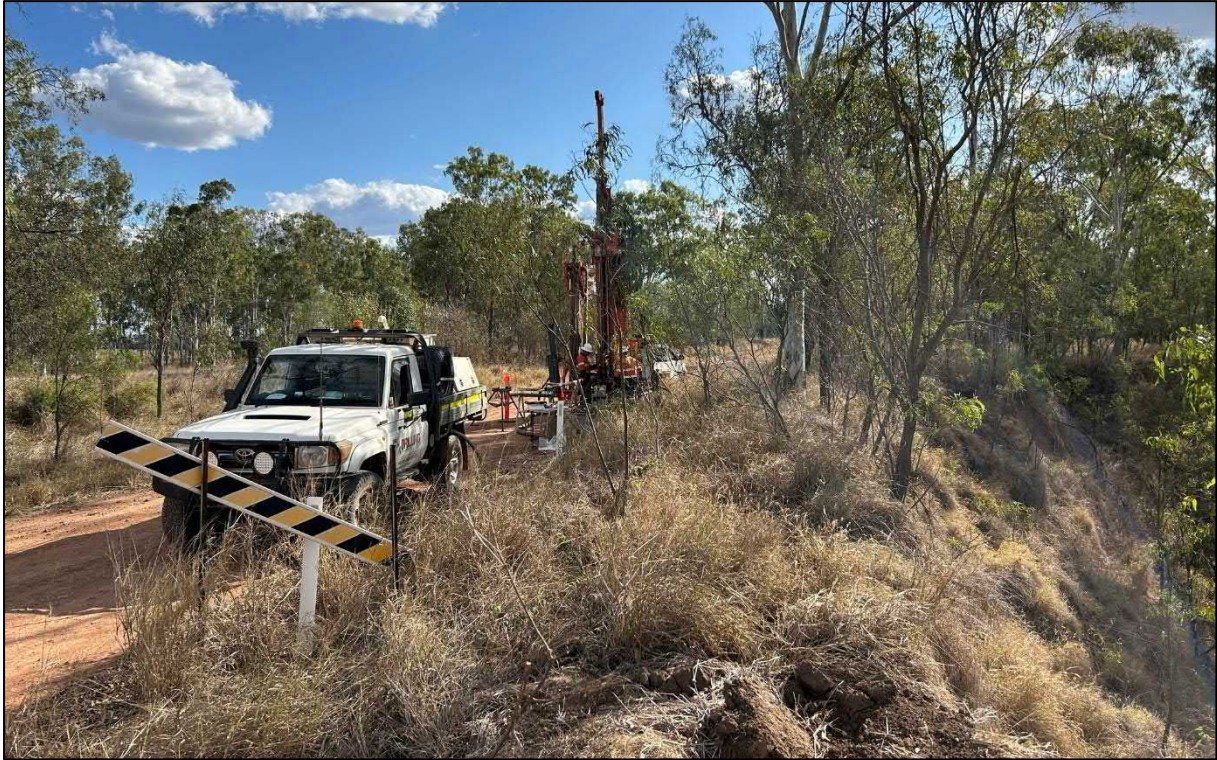
Figure 1: View of drill rig set up at Bore 2.

The riverbank (backscarp of streambank failure) was very steep and estimated to be approximately 15 m in height. The crest of the riverbank was relatively flat and level, covered with grass and vegetated with mature gum trees. The existing unsealed gravel road (Kellys Road) was setback between 2 m and 20 m from the crest of the riverbank. Photographs of typical site conditions at the time of investigation are shown in Figures 1.
