ENVIRONMENTAL ASSESSMENT REPORT

Theodore Centenary Pathway Alignment Impact Management Plan

Theodore

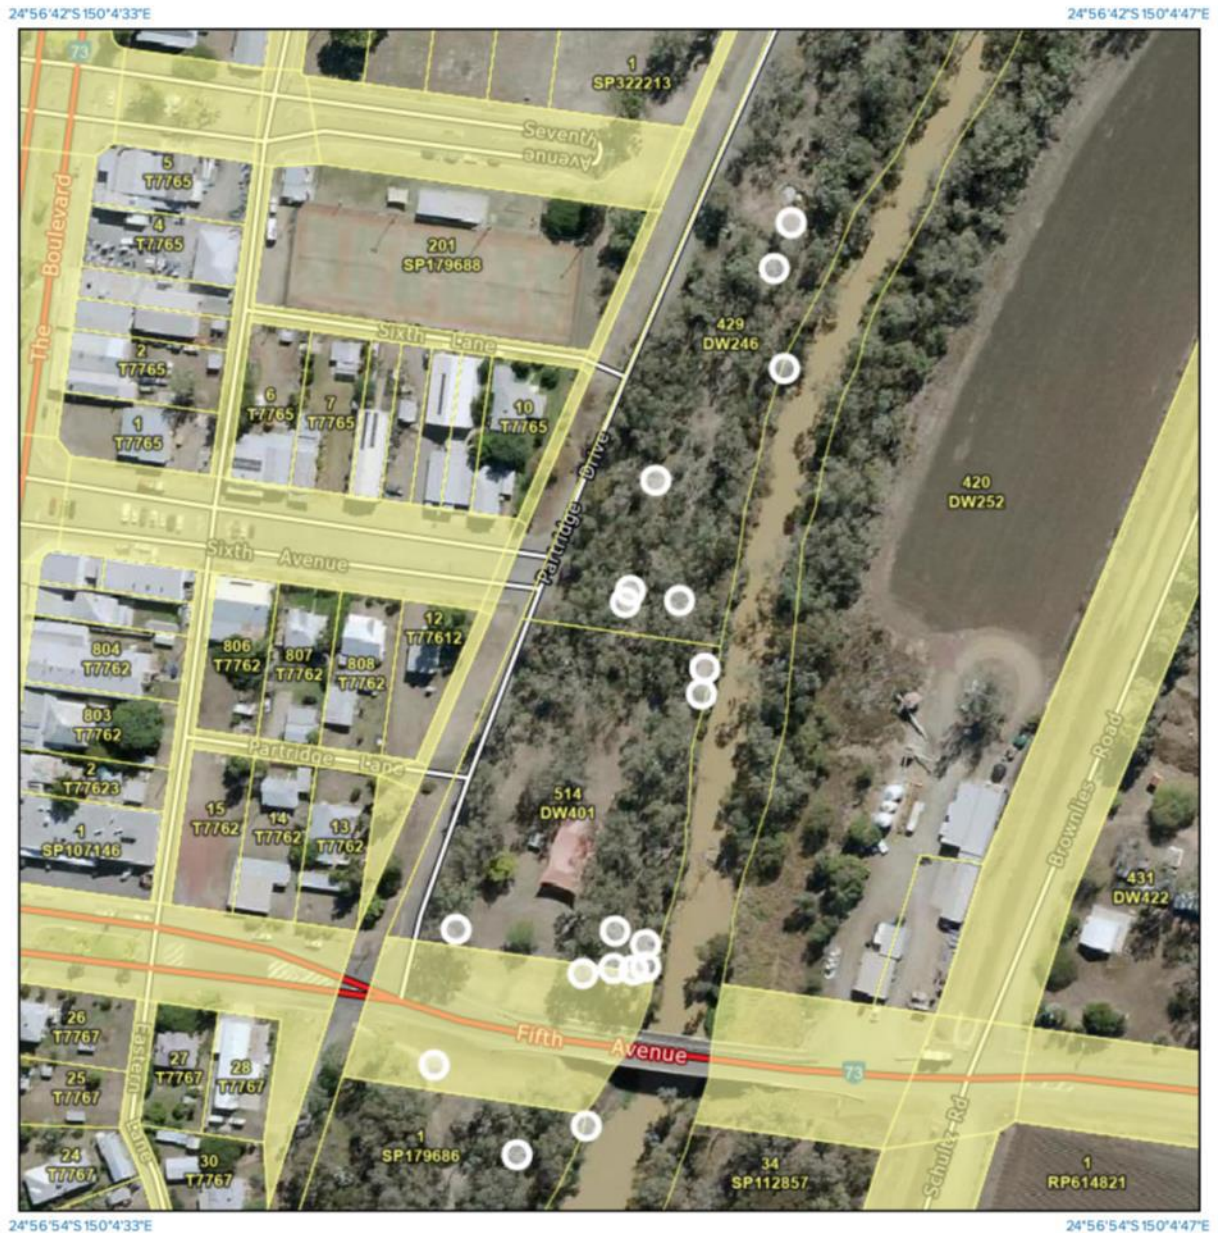
Figure 4: Mapped Location of the *Livistonia niida* within the project site

Figure 3: protected Plant Location Data within the Project Site

Protected Plant Growth Form Description Livistonia nitida	Latitude	Longitude	Description
Juv Palm	-24.9455	150.0783	X 2 juv palm sp. dropped by bird seed no mature tree
Juv Palm	-24.9456	150.0783	Single small palm 7m from pathway comm
Juv Palm	-24.9459	150.0783	Small Palm creeks edge single
Juv Palm	-24.9462	150.0779	Small single Palm wash out a 9.5 m from pathway comm
Semi Mature Palm	-24.9465	150.0778	Semi mature beside center gully drainage line
Semi Mature Palm	-24.9466	150.0778	Semi mature no fruit or flowers
Single Palm	-24.9468	150.078	Single Palm next to creek
Protected Palm	-24.9466	150.078	Single protected Palm creek side of gully
Single Palm	-24.9468	150.078	Single Palm juv riparian zone
Juv Palm	-24.9475	150.0778	Single juv Palm adjacent front creek side of skate park
Juv Palm	-24.9476	150.0777	Single juv close to bridge
Juv Palm	-24.9476	150.0778	Single creek side near bridge
Juv Palm	-24.9476	150.0778	Single creek side beside e. Tereticornis near bridge

Juv Palm	-24.9476	150.0778	Single beside creek under iron bark
Juv Palm	-24.9476	150.0776	Single adjacent bridge 6m from pathway alignment
Mature Palm	-24.9481	150.0777	Mature Palm no fruit or flowers
Juv Palm	-24.9482	150.0774	Juvenile other side of bridge off comm path
Semi Mature Palm	-24.9479	150.0772	Adjacent to existing footpath
Semi Mature Palm	-24.9475	150.0772	Small edge of park

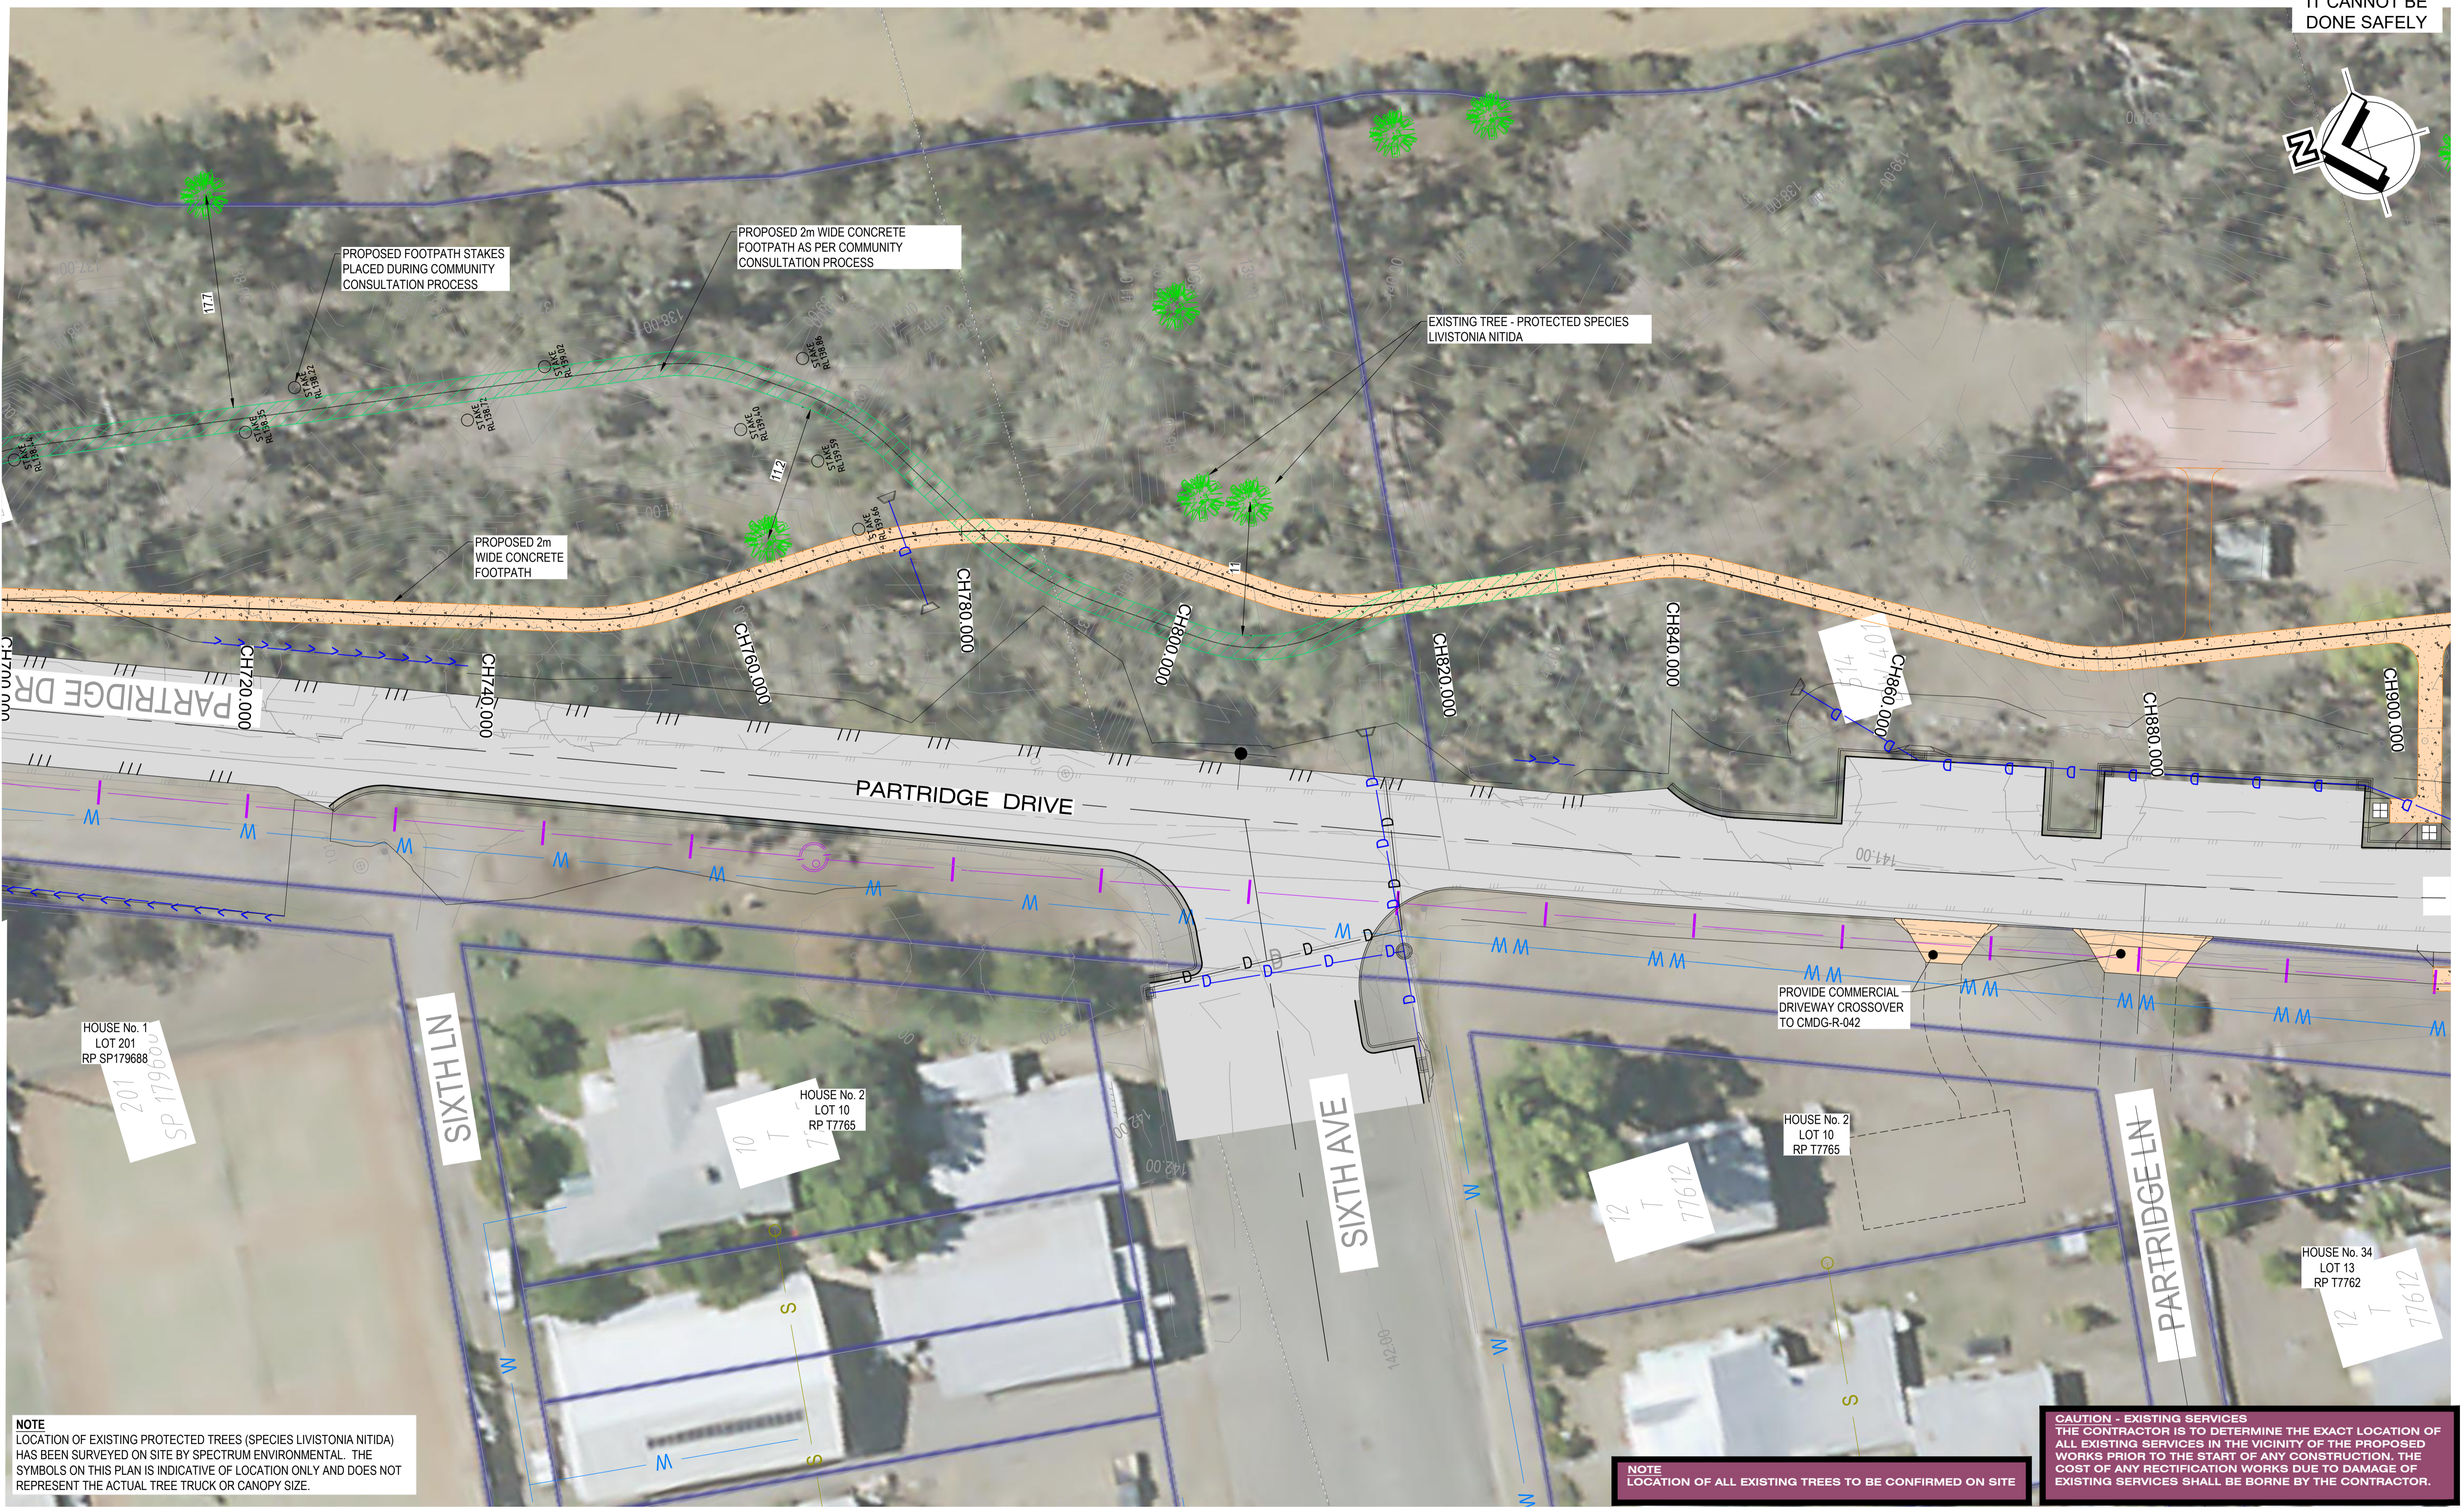
NOTE
 LOCATION OF EXISTING PROTECTED TREES (SPECIES LIVISTONIA NITIDA) HAS BEEN SURVEYED ON SITE BY SPECTRUM ENVIRONMENTAL. THE SYMBOLS ON THIS PLAN IS INDICATIVE OF LOCATION ONLY AND DOES NOT REPRESENT THE ACTUAL TREE TRUNK OR CANOPY SIZE.
